SERVICE BULLETIN

Classification: AT05-009a	Reference: NTB05-084a	Date: November 20, 2006
------------------------------	--------------------------	----------------------------

MURANO; LACK OF POWER ON TAKE OFF WITH DTC P0868 STORED IN THE TCM AND NO MIL ON

APPLIED VEHICLES: 2003 - 2007 Murano (Z50)

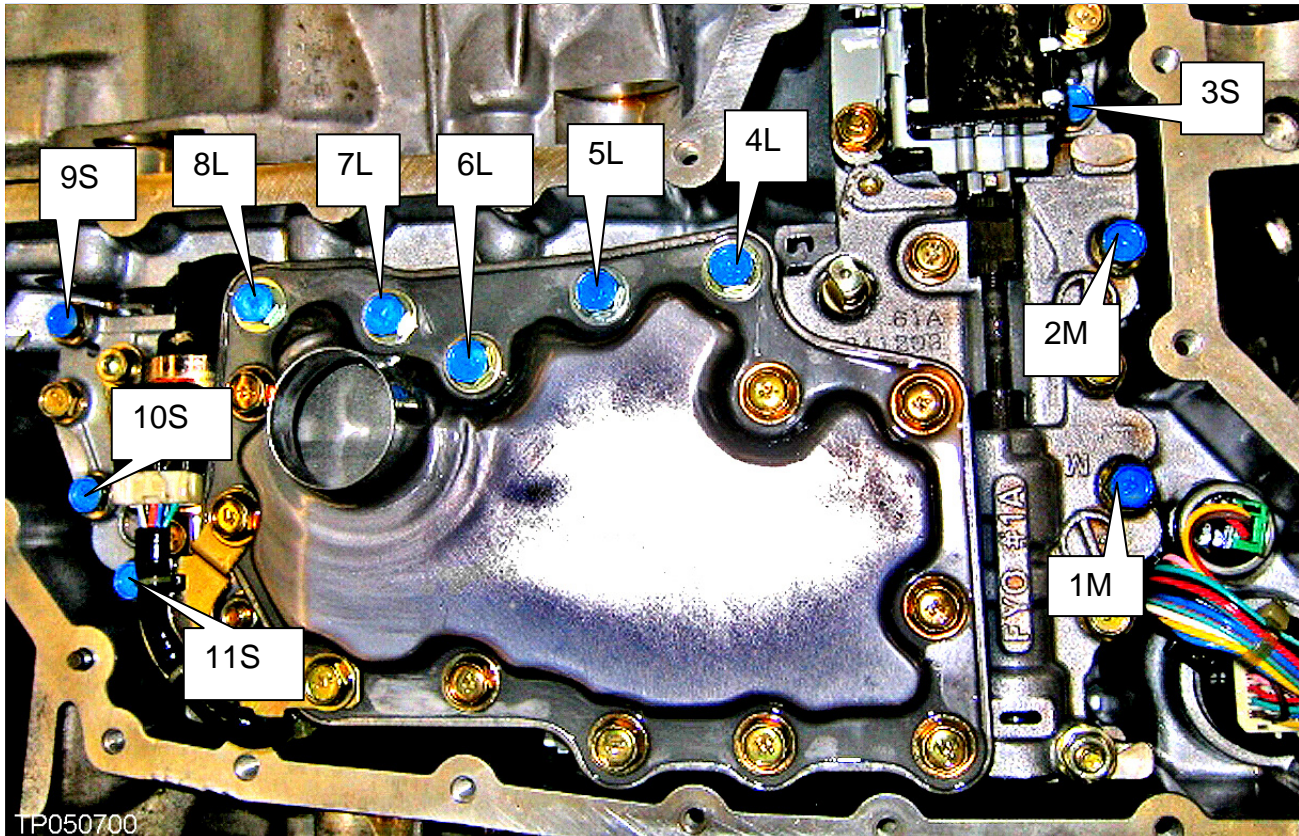
Figure 9

- There are 11 bolts shown and numbered for convenience.
- There are 3 different length bolts which are identified by:

12. Remove the bolts attaching the valve body to the transmission (see Figure 9).

19. Install and torque the 11 valve body bolts removed in Step 12 (see Figure 9).

- Tightening torque: 6.9-8.9 N m (0.7-0.9 kg-m, 61-78 in-lb).
- Torque sequence as per Figure 9: 6-7-5-8-4-9-3-10-2-11-1.
