PUNCH Powertrain

Continuously Variable Transmission

Service Manual VT2-VT3 for Haima ZZ

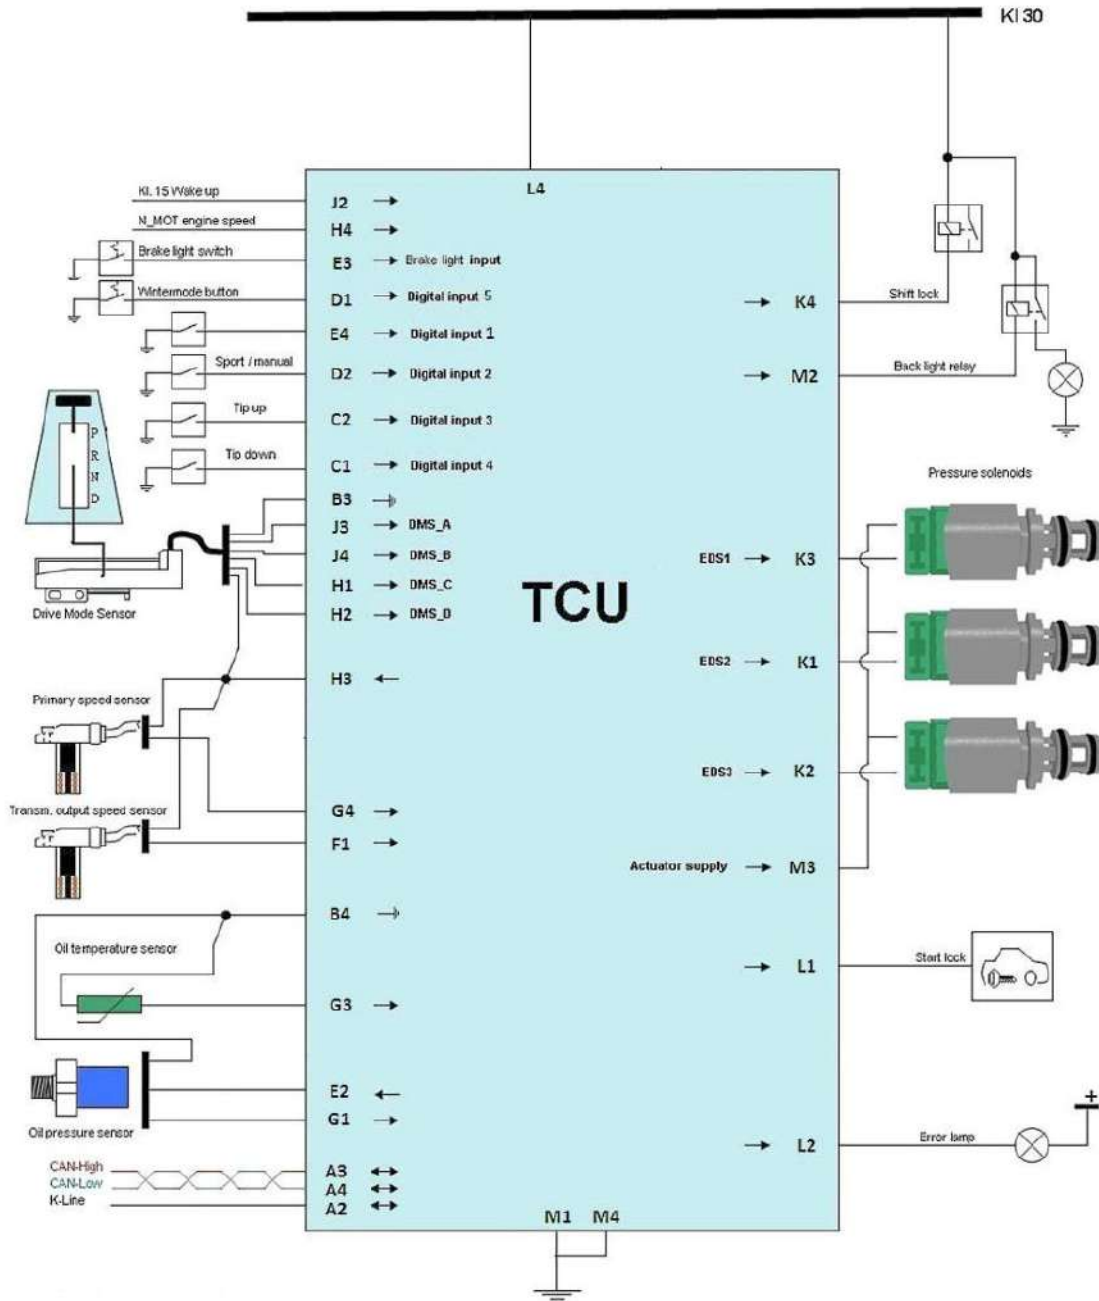
Fig.1: xTCU interfaces

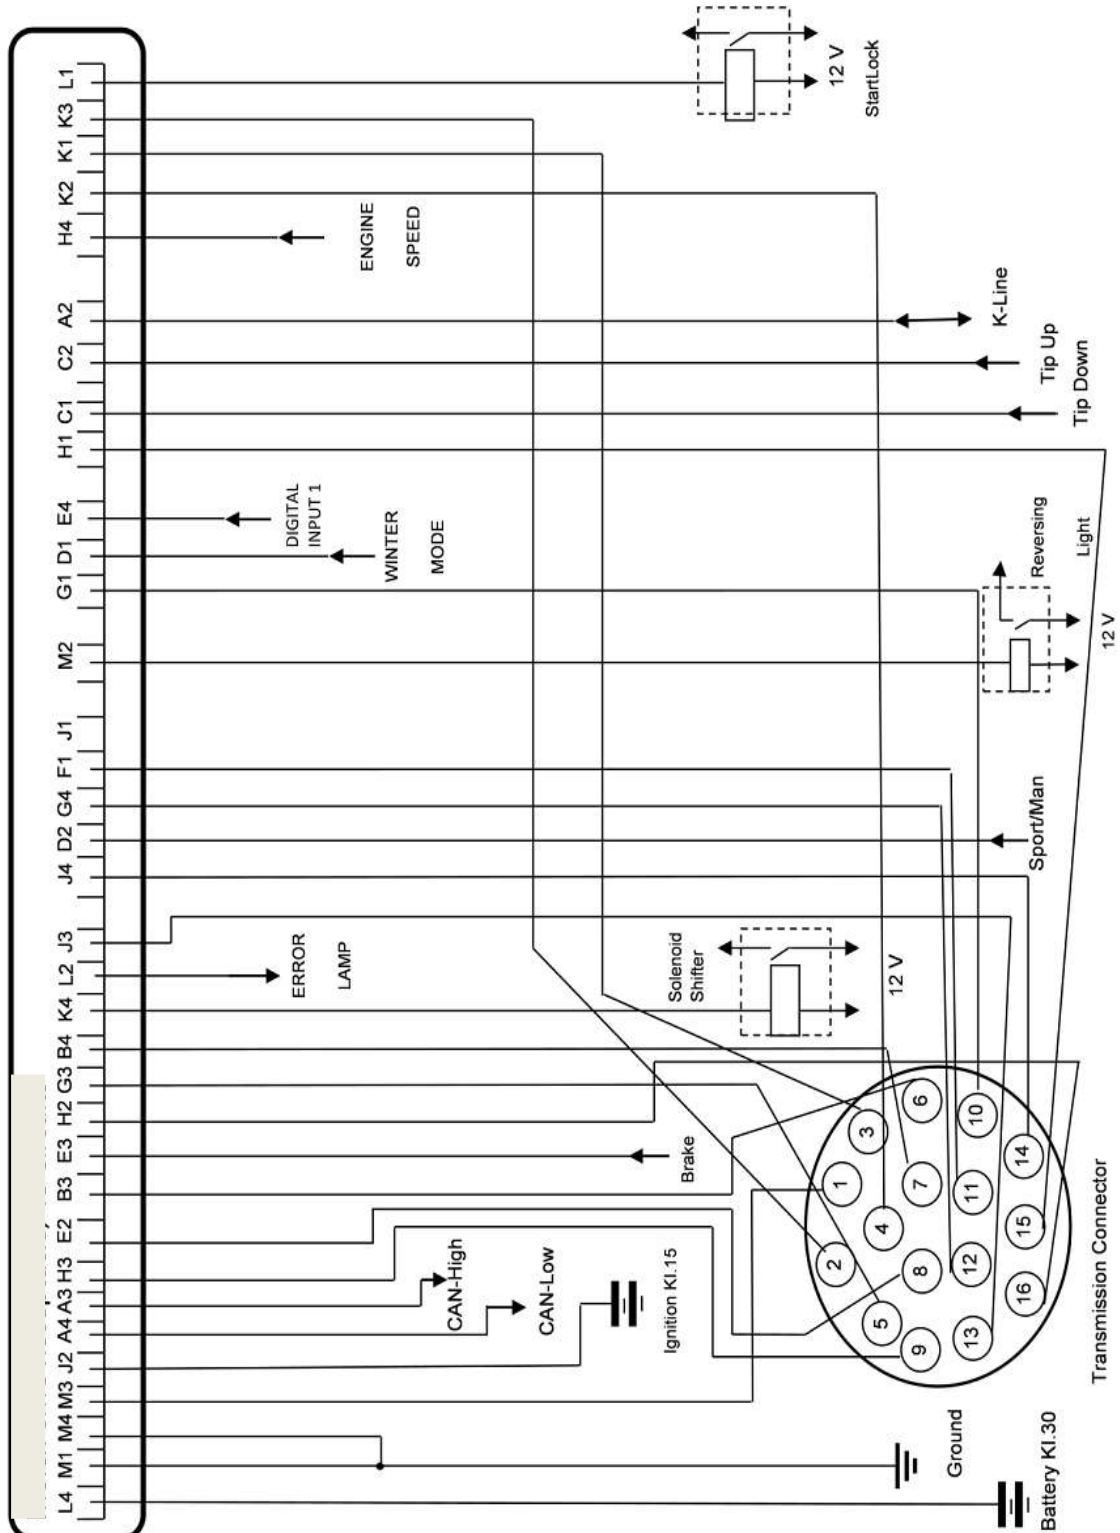
Fig.3: xTCU connection to transmission and vehicle

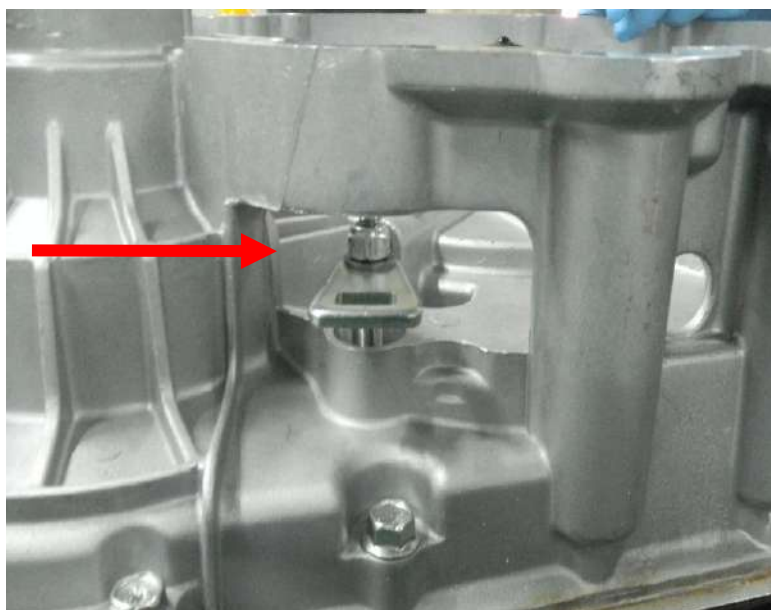
- If the shift lever is not in this position, push the shift lever manually to the outer right position:

Shift lever NOT in P position, NOT OK for cable adjustment

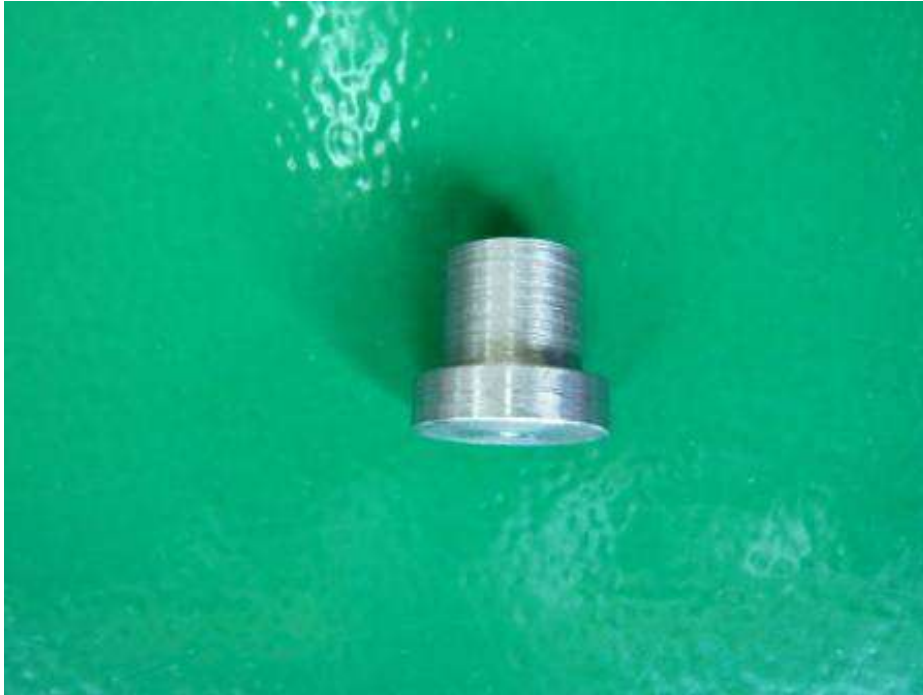
Plug – Primary bearing (drawing 480139)

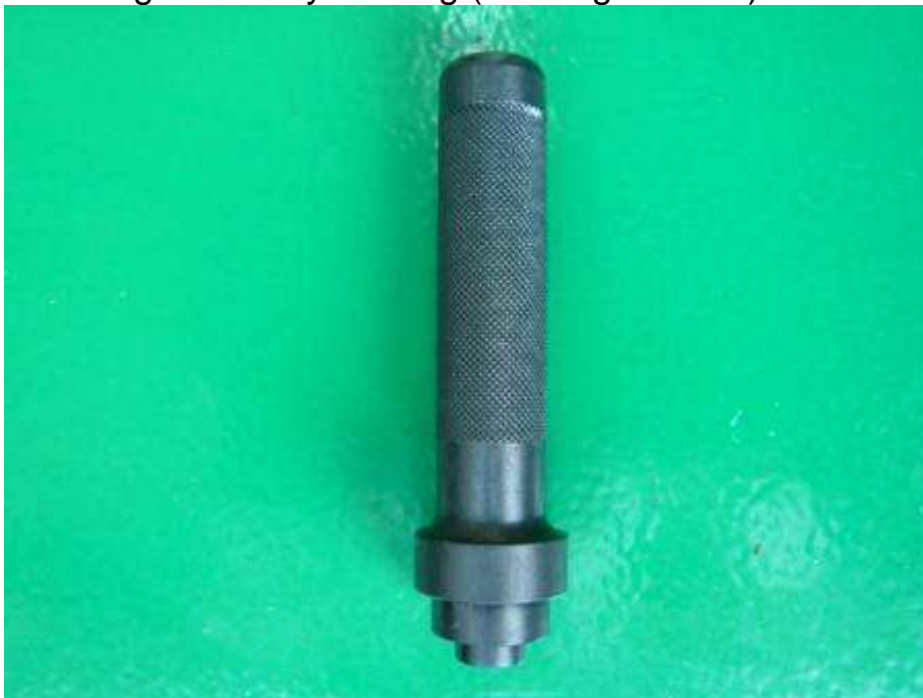
Stamp – oil seal selector shaft (drawing 480125)

- Put some vaseline or grease on the tip of the stamp (480125) (see arrow in Fig. 4-5)
- Take a new seal and slide it over the special stamp (480125) (see Fig. 4-5).
- Place special stamp tool (480125) with seal over the selector shaft and hammer in the seal until no further possible (see Fig. 4-6 and 4-7).
- Pull out the special stamp tool (480125)

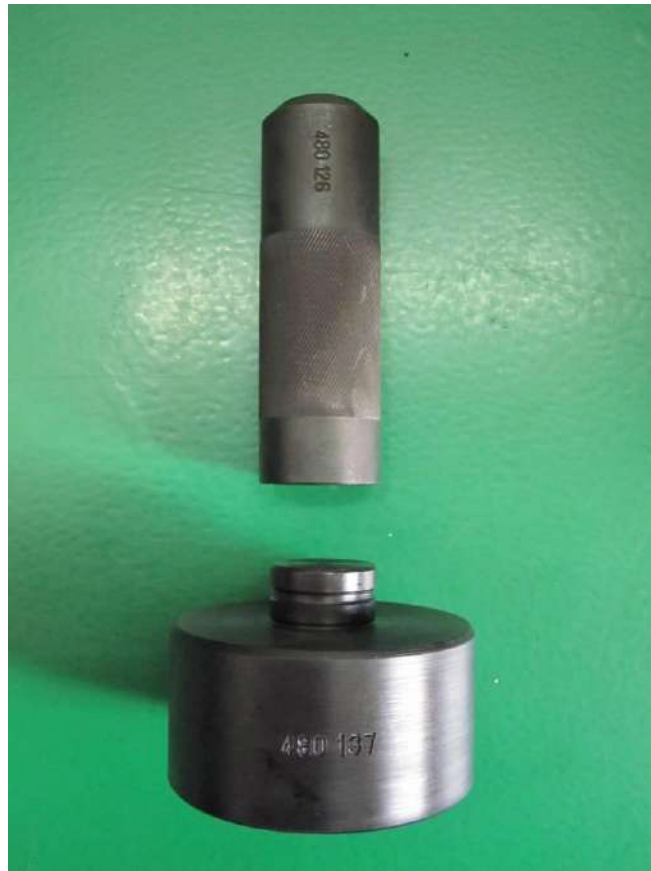
Stamp – Primary bearing (drawing 480137 + 480126)

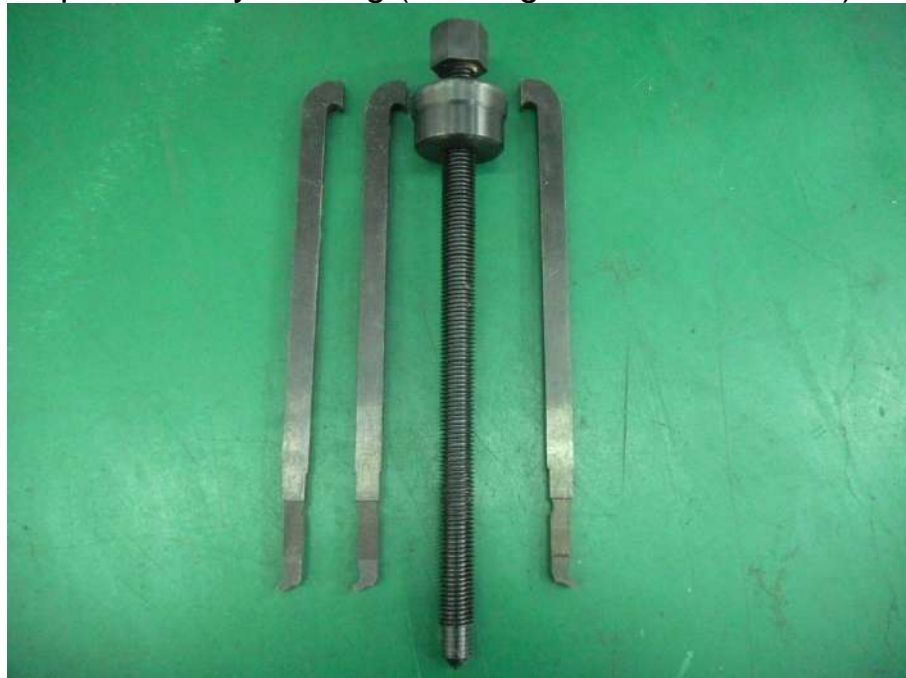
Removing tool – primary bearing (drawing 480136)

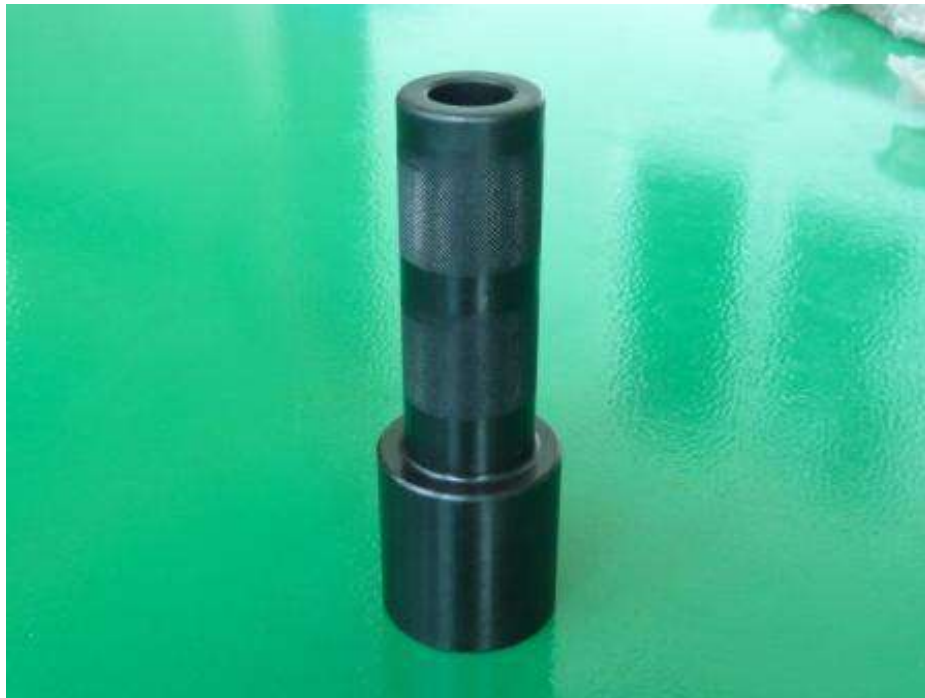
Stamp – oil seal input shaft (drawing 480130)

- Place the special stamp tool (480130) on input shaft (see Fig. 3-4)
- Hit the special stamp tool with rubber hammer until no further is possible
- Remove special tools and refit transmission in vehicle
- Refill transmission according instruction (see 2.1)

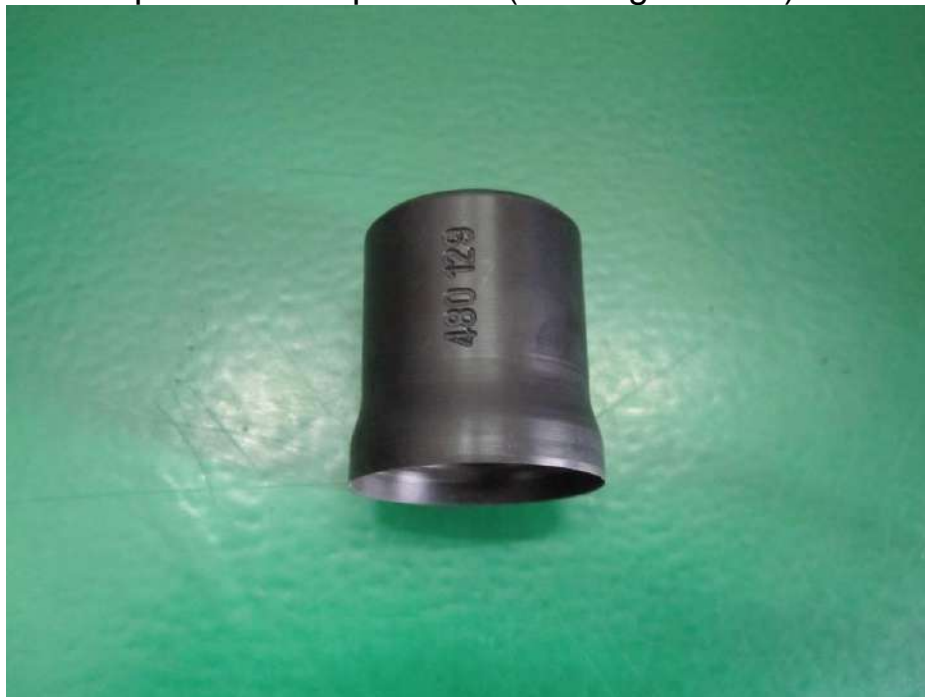
Centering bush – oil seal input shaft (drawing 480129)

- Place the special guiding tool (480129) on input shaft (see Fig. 3-2)
- Slide a new seal over the guiding tool (see Fig. 3-3)

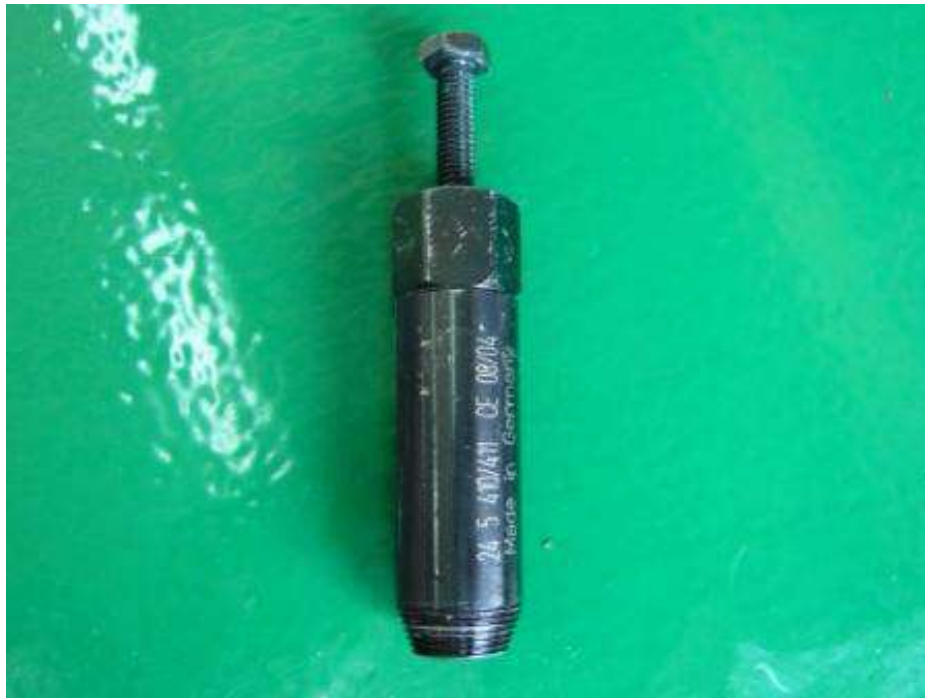
Removing tool – oil seal selector shaft (drawing 480127)

- Drain the oil of the transmission (see changing oil filter)
- Remove the transmission from the car
- Remove lever selector shaft
- Place special tool (480127) over the selector shaft (see Fig. 4-1)

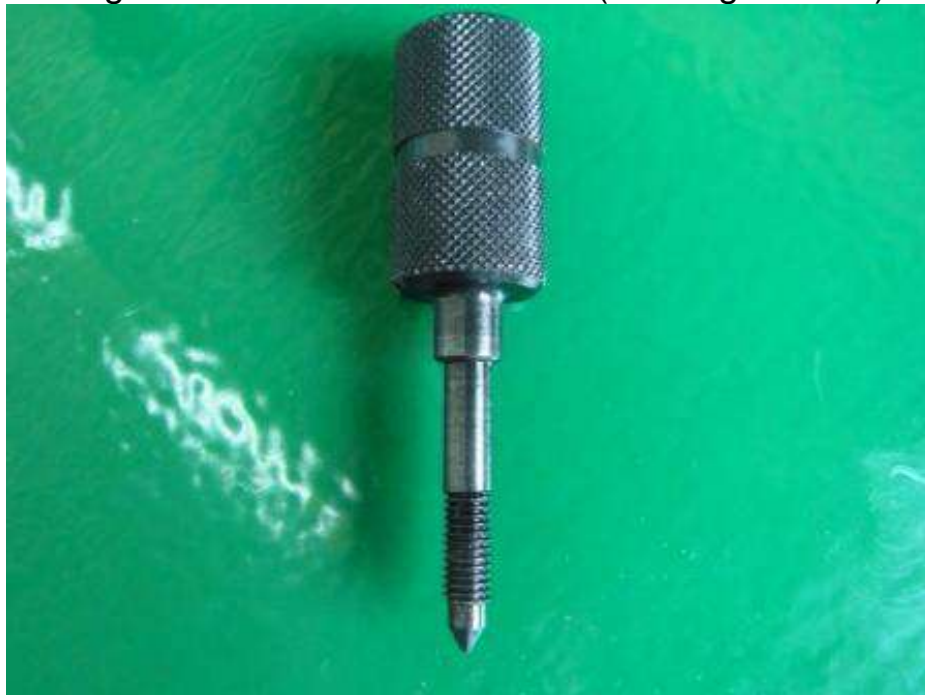
Centering pin – hydraulic unit (drawing 480142)

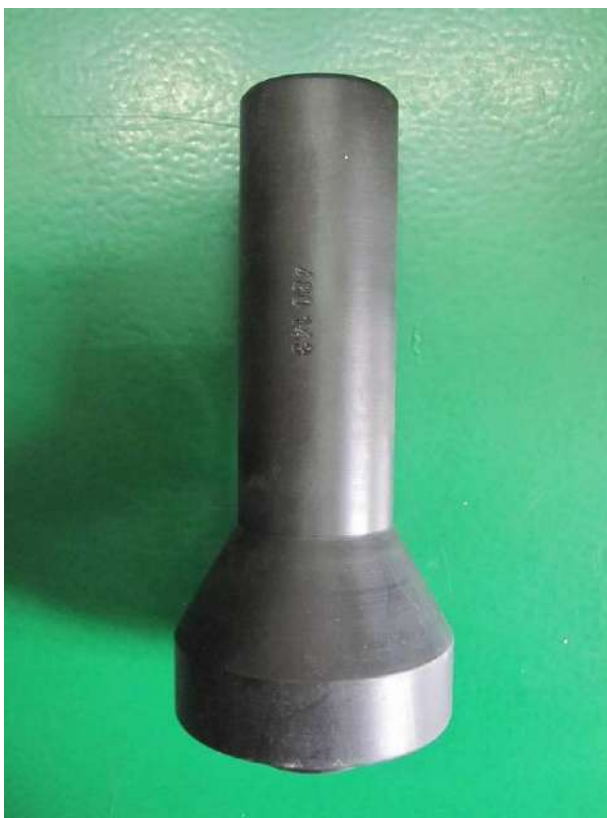
Stamp – oil seal differential (drawing 480143)

- Take a new seal and put it in the housing (see Fig. 2-2)
- Place the special tool (480143) on the seal and use a rubber hammer to knock oil seal into the housing. Hammer it all the way in until no further is possible
- The depth of the oil seal should now be $3\text{mm} \pm 0.3\text{mm}$ from the edge of the housing
- Replace the half shaft if necessary
- Refill transmission according instruction (see 2.1)

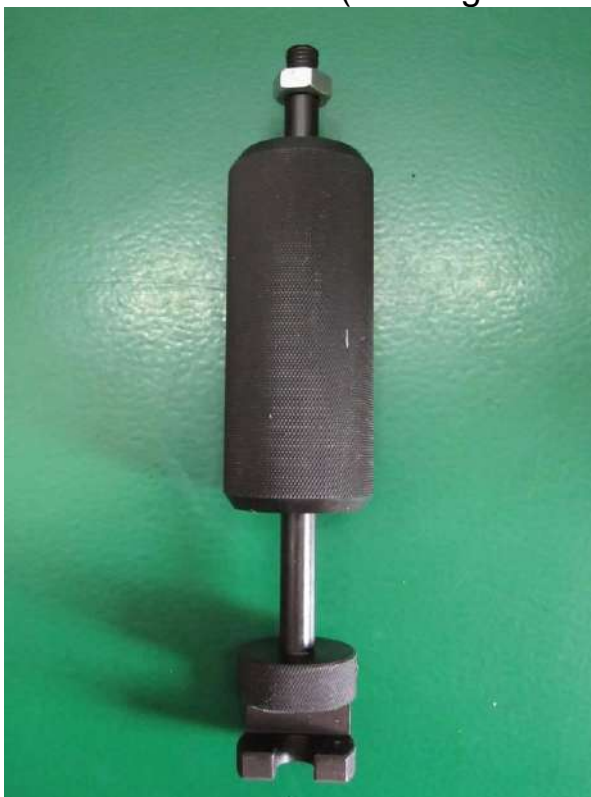
Removing tool – pump (drawing 480141)

- Follow the steps to remove the primary cover
- Remove the 6 pump bolts and place special tool (480141) (see Fig. 6-1)
- Pull the sliding part of the tool a few times to lift out the pump (see Fig. 6-2).
- Replace the pump with a new one. Make sure you put 2 new O-rings and 1 plastic snap ring on the new pump. Do not take out the Belle-ville washer and leave it in its correct position which is biggest diameter facing the pump (see Fig. 6-3)
- Put the 6 screws back and tighten with (10Nm +/- 1Nm)
- Follow the steps to close back the primary cover, no need to take new primary cover O-ring and primary cover

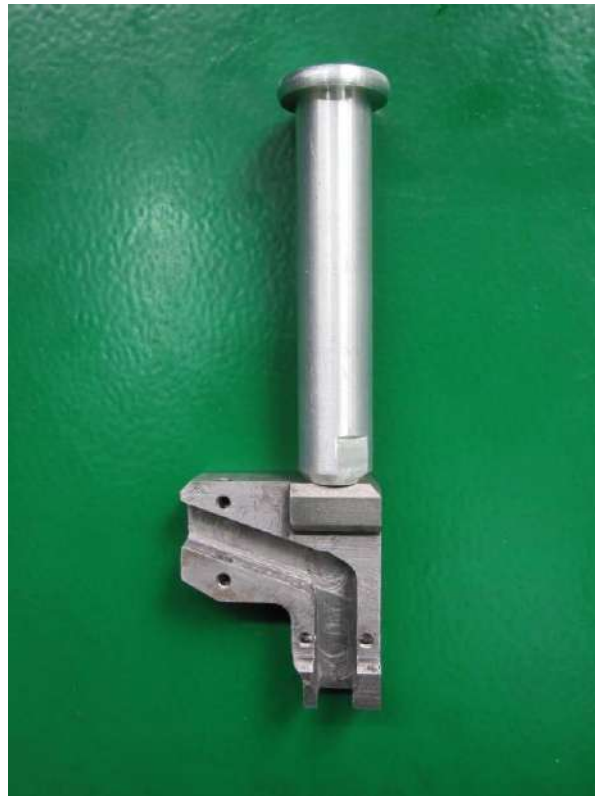
Assembly tool – breather pipe (drawing 480140)

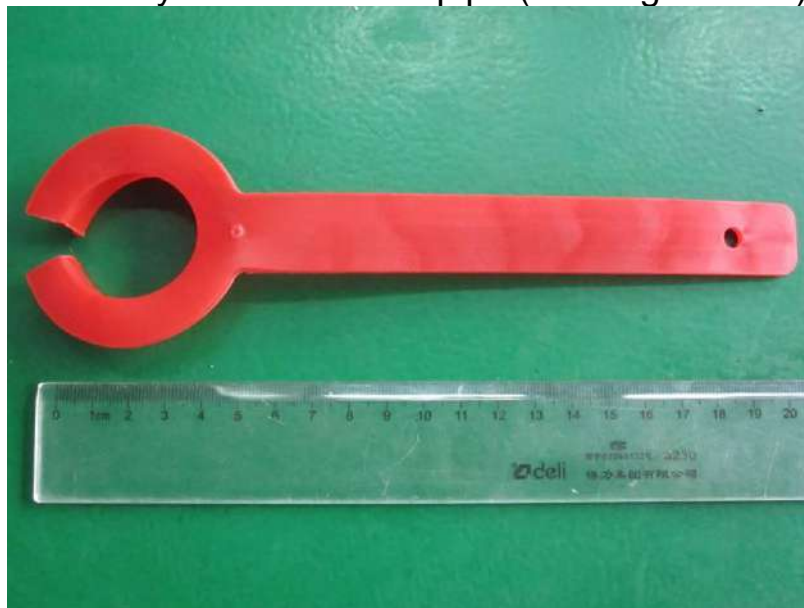
Assembly tool drive shaft (drawing 48154)

During the assembly of the drive shafts into the transmission, we strongly recommend to use Punch Tool 480145 in order to protect the oil seal at the differential.

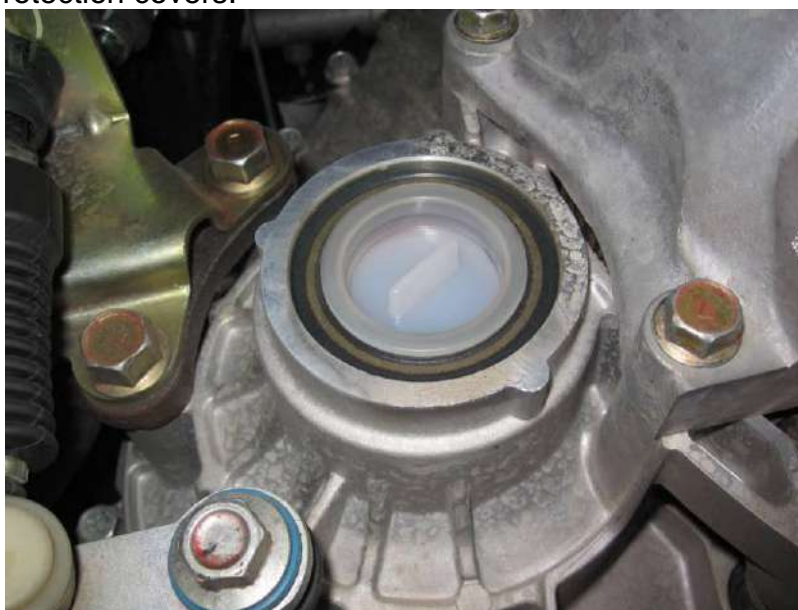
-Remove the protection covers:

Fig. 1-1: Protective covers for differential seal

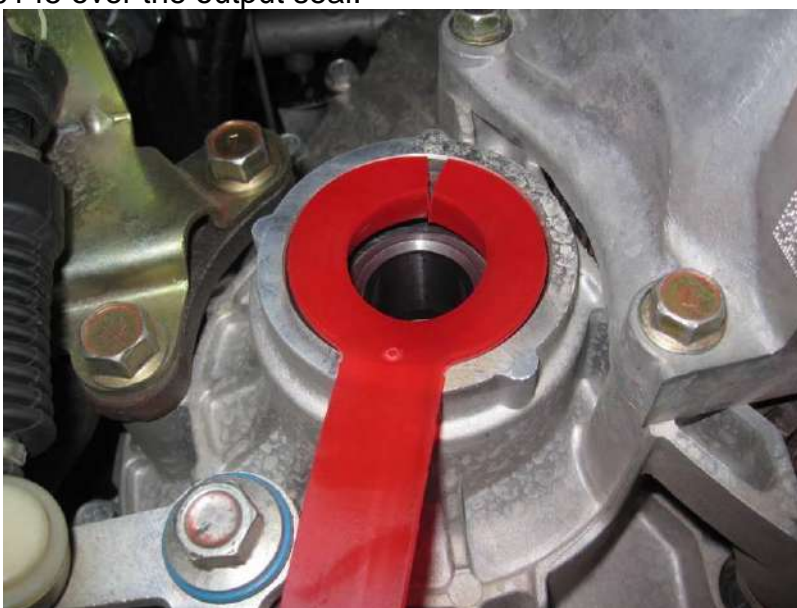
-Install tool 480145 over the output seal:

Fig. 1-2: Assembly tool drive shaft 480145 mounted

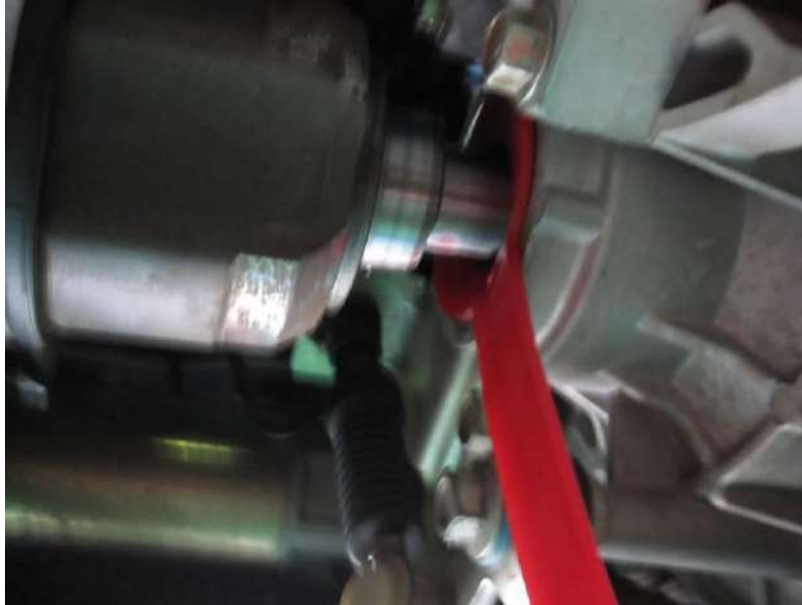
-Insert drive shaft for max 4cm into the transmission:

Fig. 1-3: Drive shaft inserted for 4cm

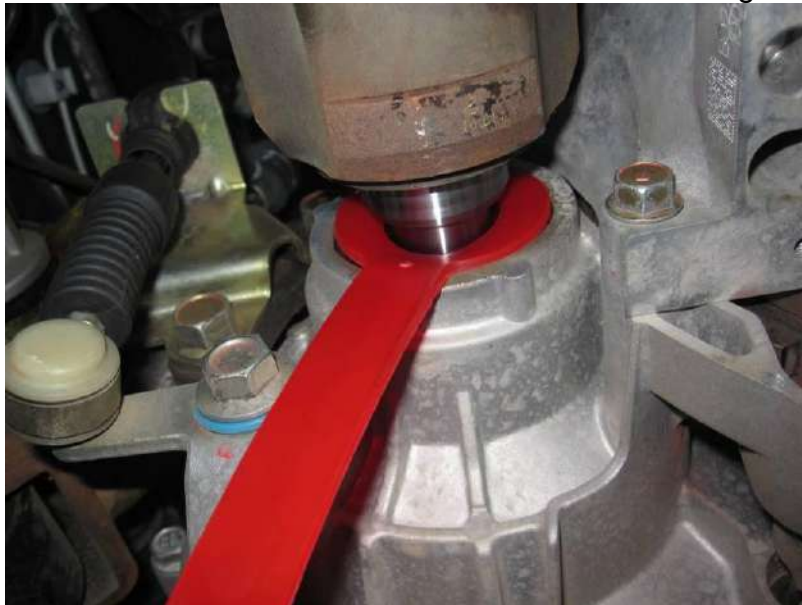
-Stop and leave 2 cm distance between the driveshaft and mounting tool:

Fig. 1-4: 2 cm distance between drive shaft and tool 480145

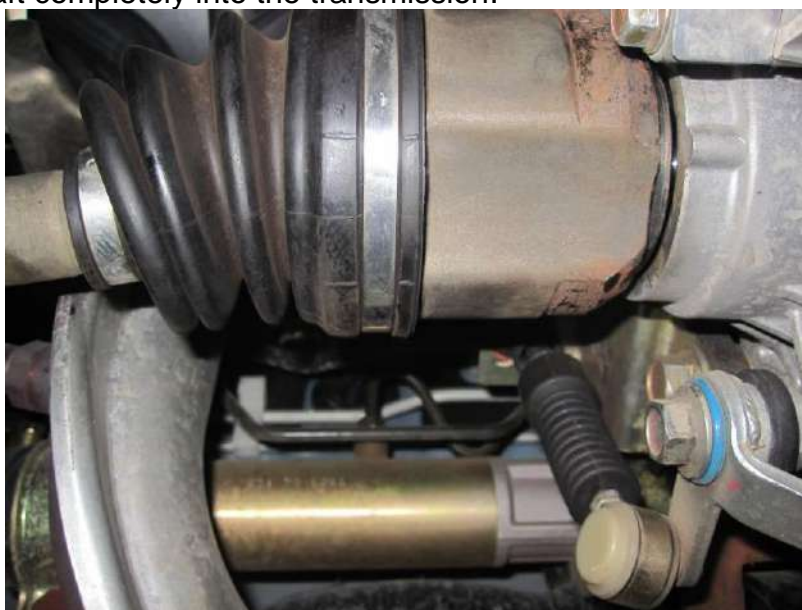
-Push driveshaft completely into the transmission:

Fig. 1-6: Drive shaft mounted

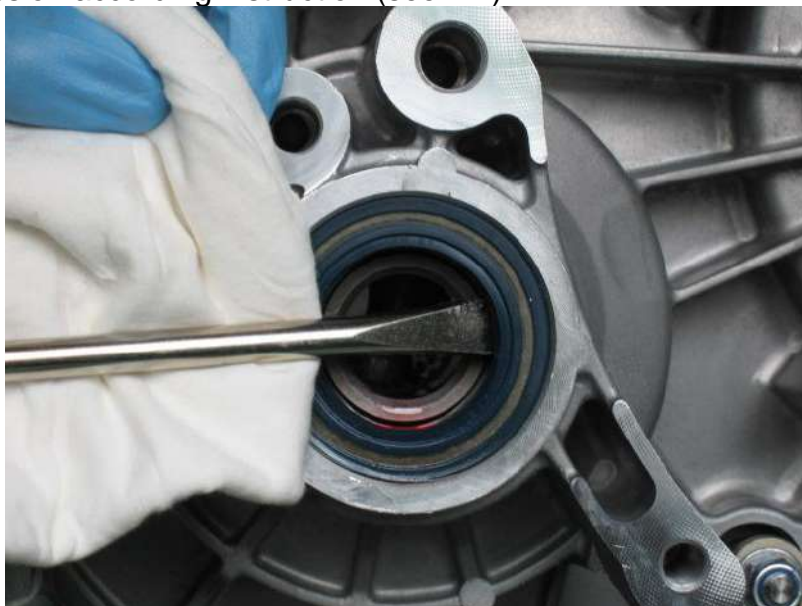
Fig. 2-1: Remove oil seal

- Drain the oil of the transmission (see changing oil filter)
- Remove half shaft
- use a big screwdriver to pinch out the seal. Be careful not to put screwdriver in too deep, otherwise the housing can be damaged by the tip of the screwdriver (see Fig. 2-1)
- Discard the old oil seal

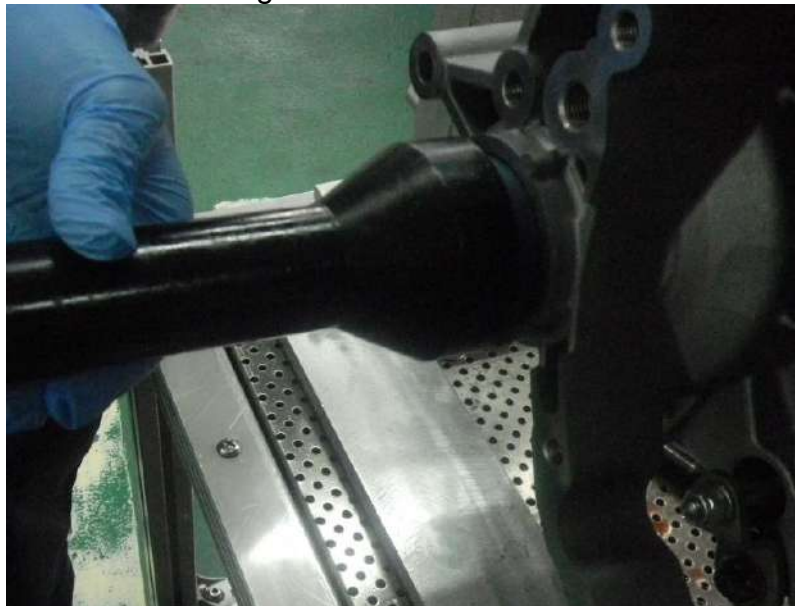
Fig. 2-2: Installing new seal with special tool

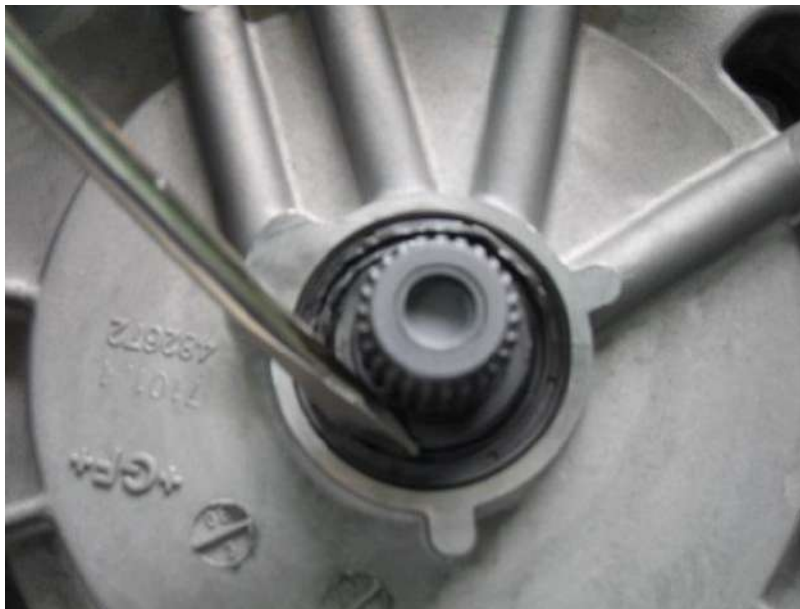
Fig. 3-1: Remove input shaft seal

- Remove the transmission from the car
- Use a big screwdriver to peel out the seal from the transmission (see Fig. 3-1). Peel out the seal from the inside of the seal by going around and around. Be careful not to damage the input shaft
- Discard the old oil seal

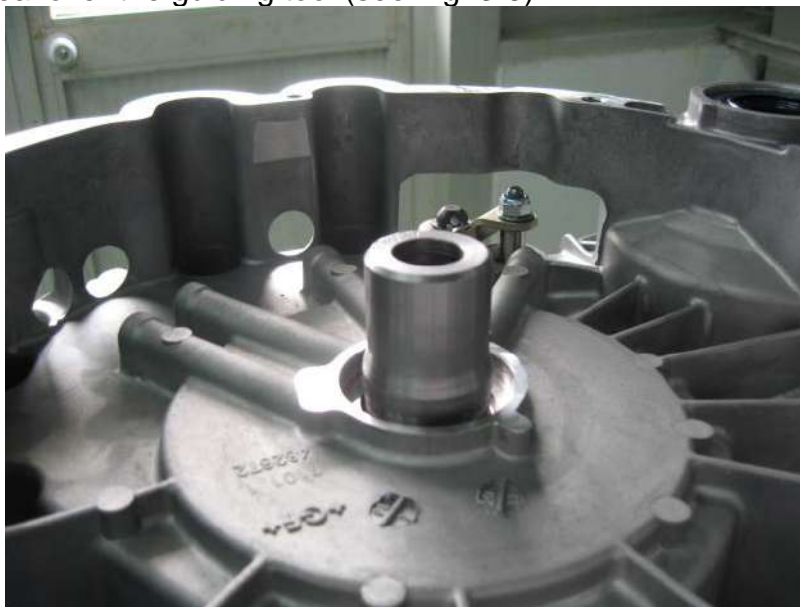
Fig. 3-2: Put special tool on input shaft (480129)

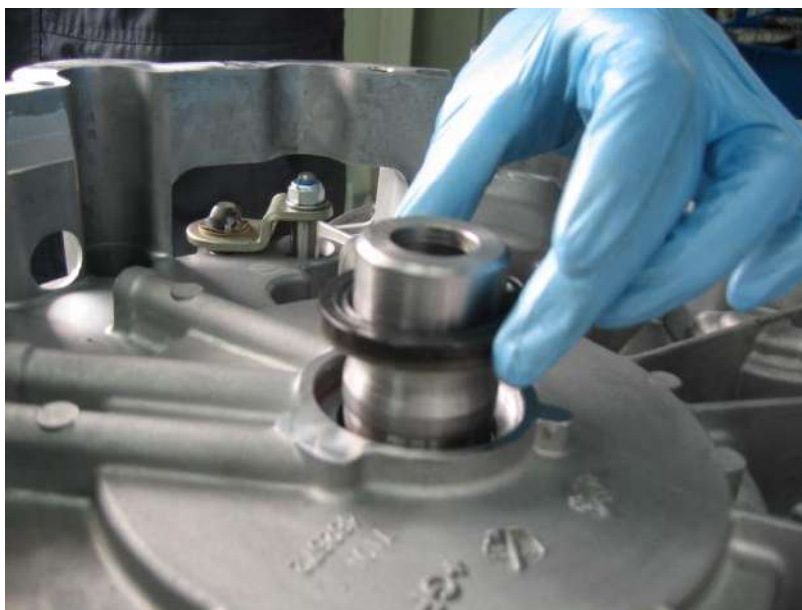
Fig. 3-3: Press the oil seal

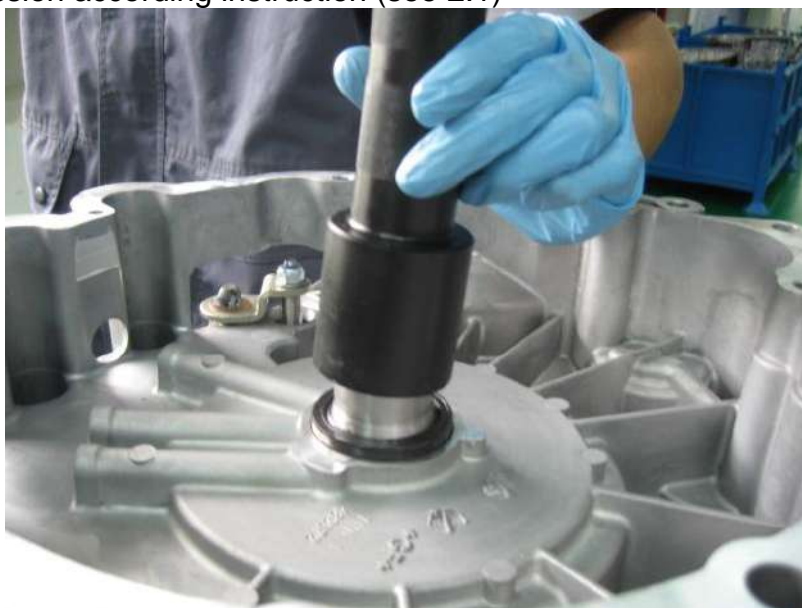
Fig. 3-4: Installing seal by special stamp (480130)

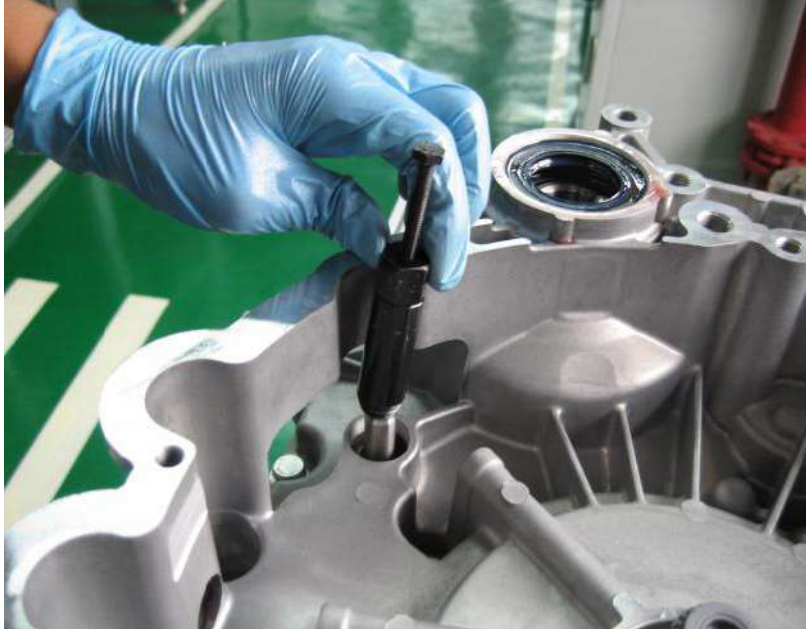
Fig. 4-1: Put special tool (480127) on shaft

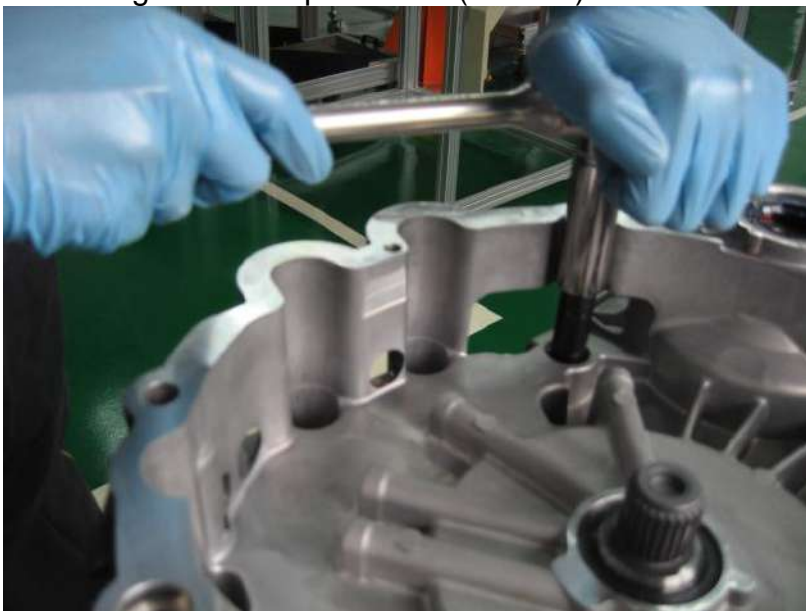
Fig. 4-2: Press and screw tool clockwise

- Screw in the special tool with wrench. Push on top of the wrench so the tool has the ability to screw itself into the seal (see Fig. 4-2)
- Screw in the screw on top of the special tool to lift out the seal (see Fig. 4-3)
- Discard the seal (see Fig. 4-4)

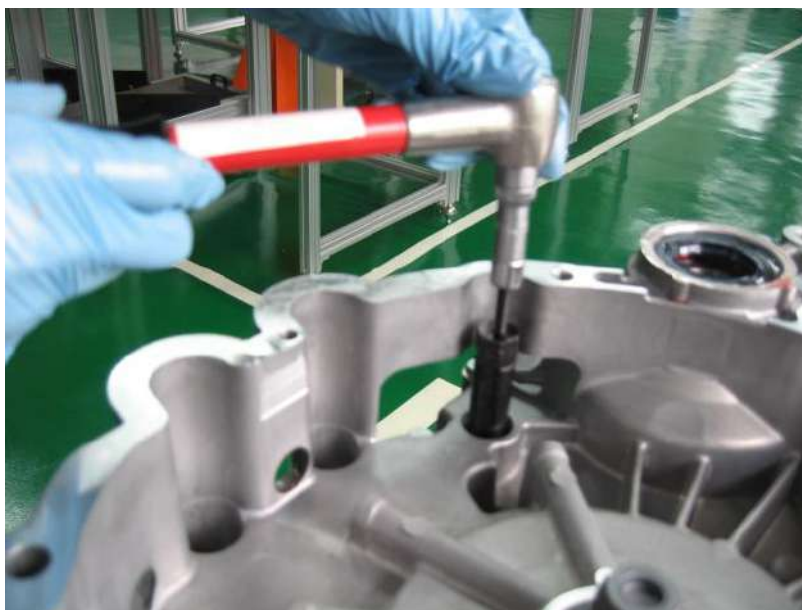
Fig. 4-3: Rotate screw to remove the seal

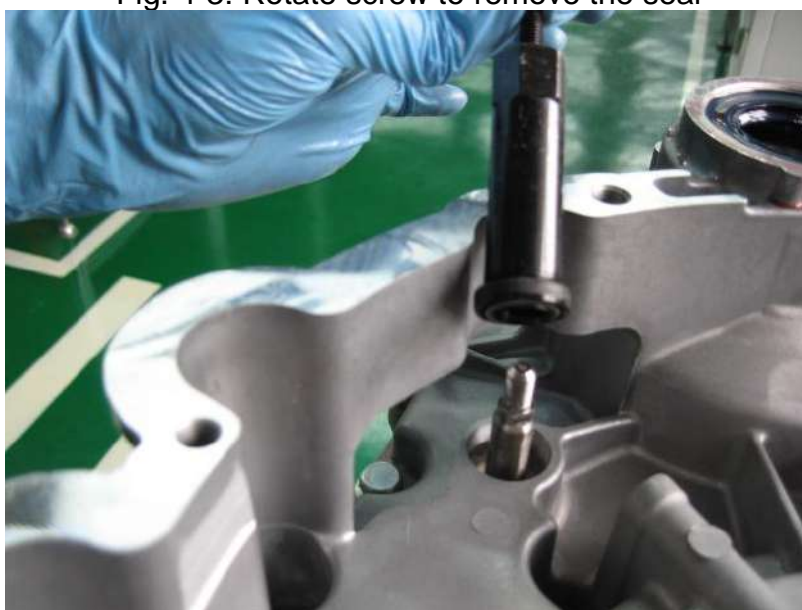
Fig. 4-4: Remove the oil seal

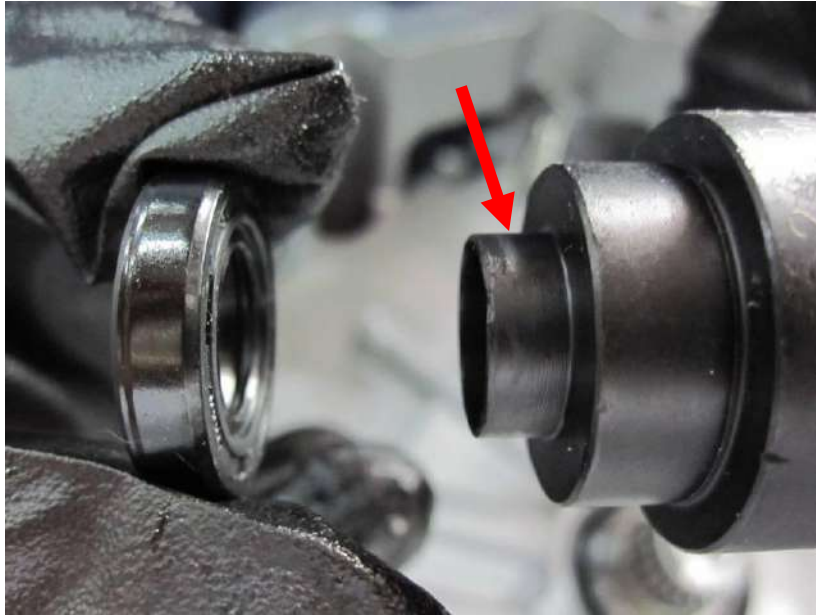
Fig. 4-5: Slide the seal over the special stamp (480125)

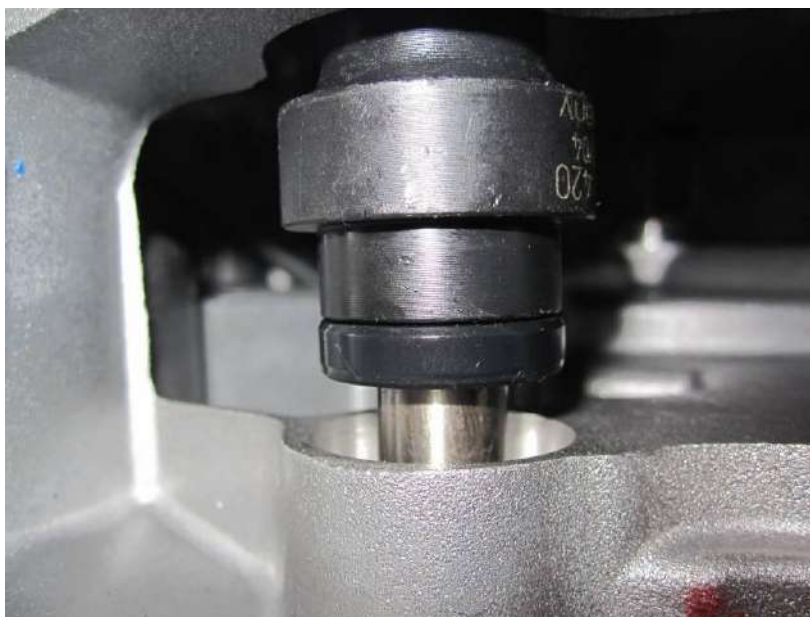
- Fig. 4-7: Hammer down special stamp (480125) with seal till no further is possible
- Remove the stamp while rotating, otherwise there is the possibility the seal comes back out with the stamp
 - Remount the lever selector shaft with new washer (482584) and nut (481329).
 - Tighten the nut with $14.5\text{Nm} \pm 1.5\text{Nm}$
 - Refit transmission in vehicle
 - Refill transmission according instruction (see 2.1)

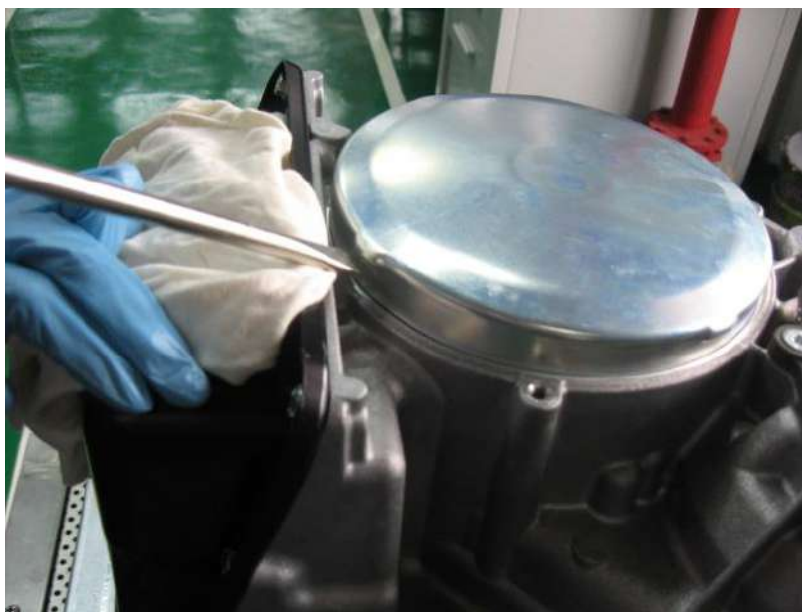
Fig. 5-1: Remove primary cover from transmission

- Drain approx. 1litre of oil out of the transmission (see replacing oil filter)
- The transmission does not need to be removed from the vehicle but may be lowered together with the engine for easier access
- Loosen the three bolts and clips which are fixing the primary cover to the housing.
- Use a screwdriver to lift out the primary cover. Use some cloth to protect the transmission from damage (see Fig. 5-1)
- Remove the big O-ring and discard both O-ring and primary cover
- Take a new O-ring and assemble it
- Replace a new primary cover and fix clips and bolts with a torque of $9.5\text{Nm} \pm 2.5\text{Nm}$
- Refill transmission with 1litre of oil

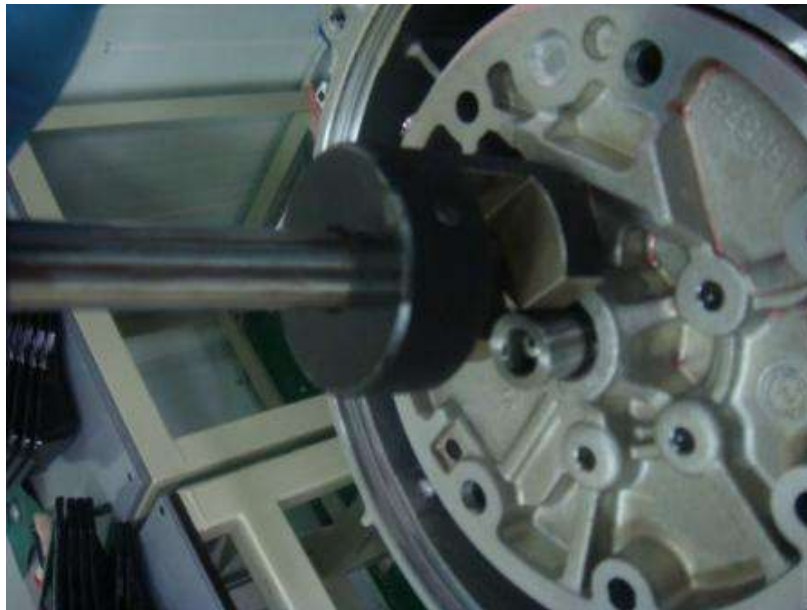
Fig. 6-1: Remove six bolts and place tool (480141)

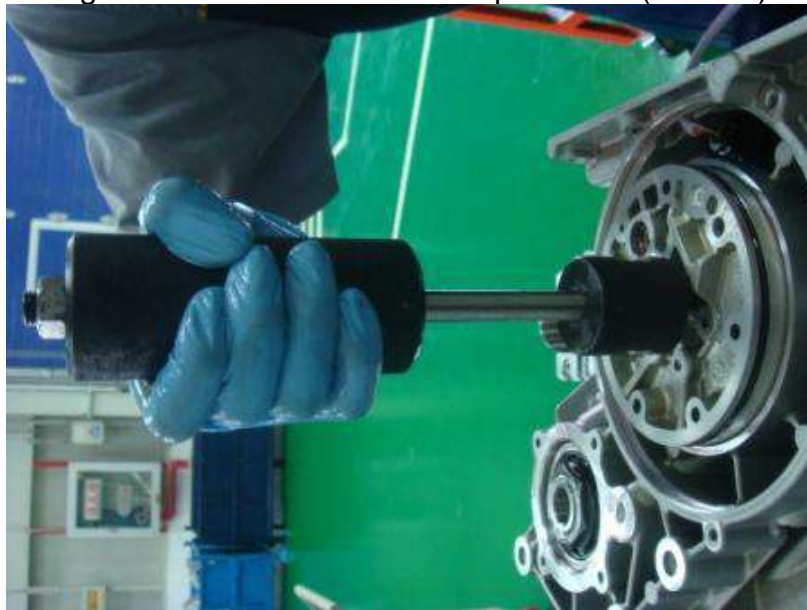
Fig. 6-2: Pull the tool to lift out pump

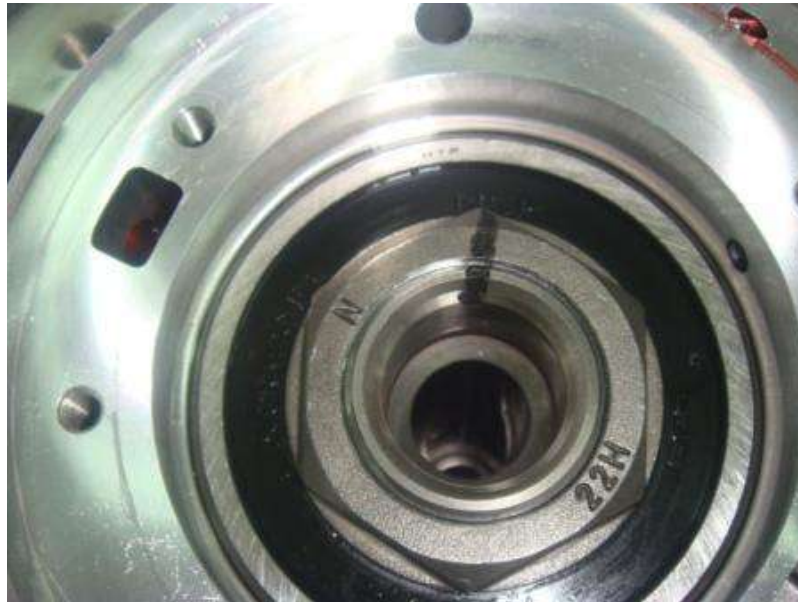
Fig. 7-1: Mark primary nut and shaft

- Follow the steps to remove the oil pump
- Remove Belle-ville washer
- Mark the position of the primary nut on the shaft (see Fig. 7-1)
- Using an air impact wrench with a torque capacity of +/-300Nm, remove the primary nut

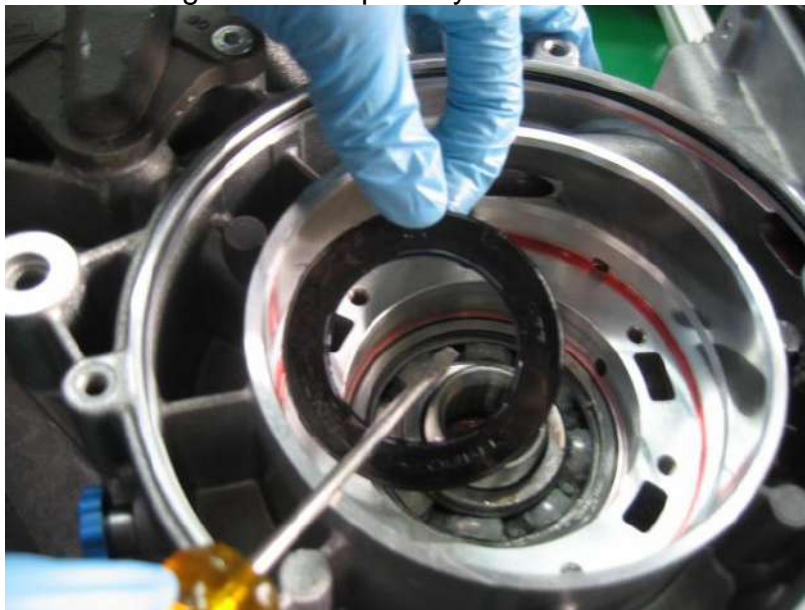
Fig. 7-2: Lever out seal from primary bearing

- Lever out the seal of the primary ball bearing using a small screwdriver (see Fig. 7-2)
- Place the special tool primary plug (480139) (see Fig. 7-3)
- Assemble the bearing puller (480136) underneath the exterior ring of the primary bearing (see Fig. 7-4)
