PUNCH Powertrain

Continuously Variable Transmission

Service Manual VT2-VT3 for Haima ZZ

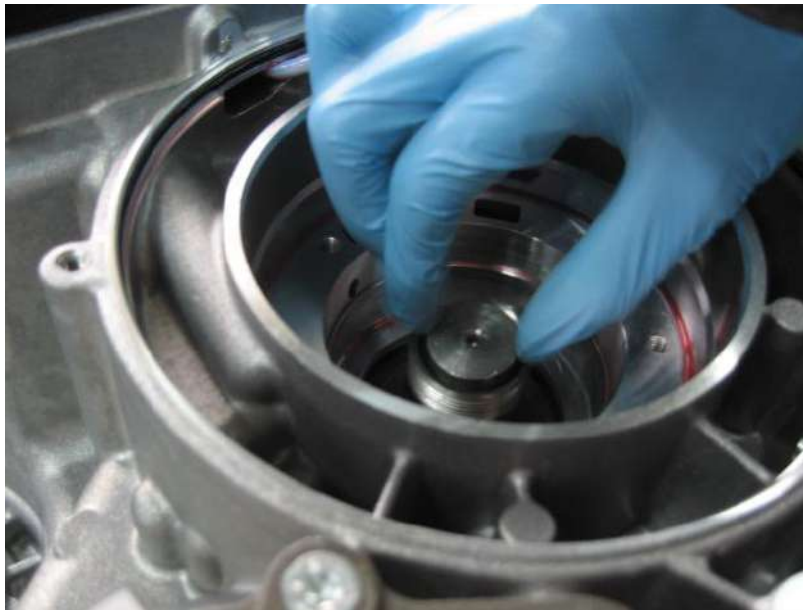
Fig. 7-3: Put special tool on shaft (primary plug 480139)

- Lever out the seal of the primary ball bearing using a small screwdriver (see Fig. 7-2)
- Place the special tool primary plug (480139) (see Fig. 7-3)
- Assemble the bearing puller (480136) underneath the exterior ring of the primary bearing (see Fig. 7-4)

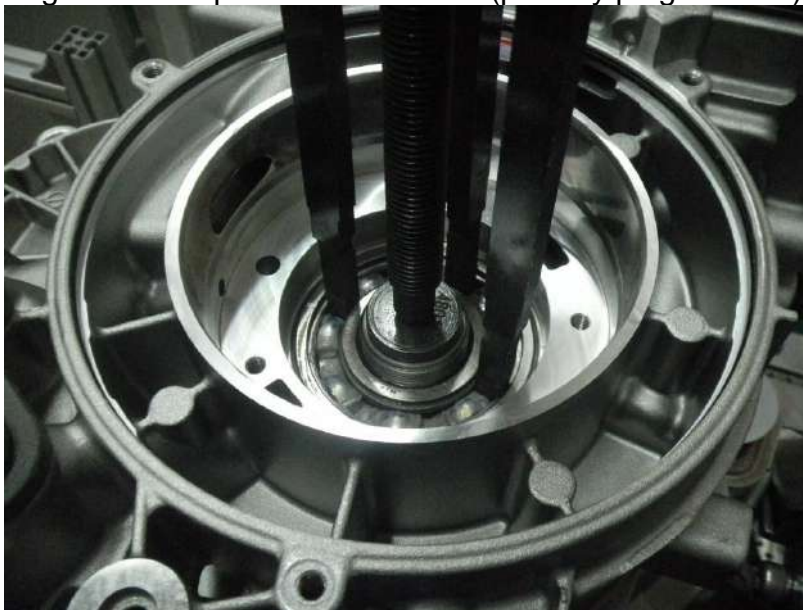
Fig. 7-4: Assemble bearing puller (480136)

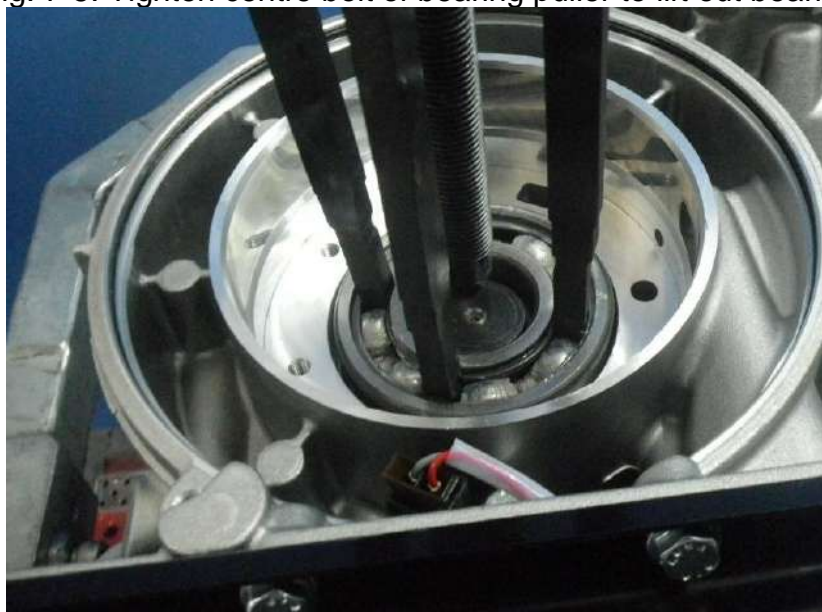
Fig. 7-6: Remove primary bearing

- Remove primary bearing by tightening the centre bolt of the bearing puller (see Fig. 7-5)
- Discard primary bearing, clean primary shaft, clean sealant from threads in oil pump drive shaft and clean oil pump housing (see Fig. 7-6)

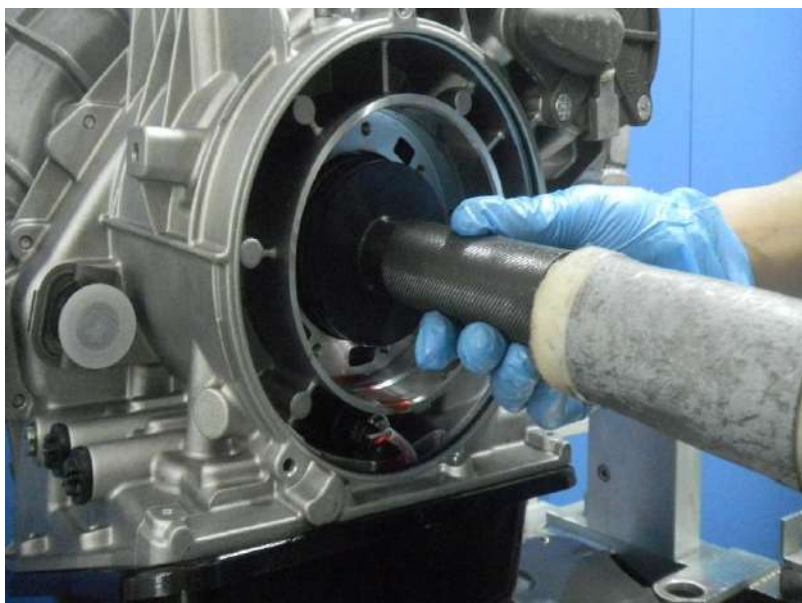
Fig. 7-7: Fit new primary ball bearing

- Place a new bearing on the primary shaft and use special stamp tool (480137 + 480126) to put bearing in. Use rubber hammer and hit until no further possible (see Fig. 7-7)

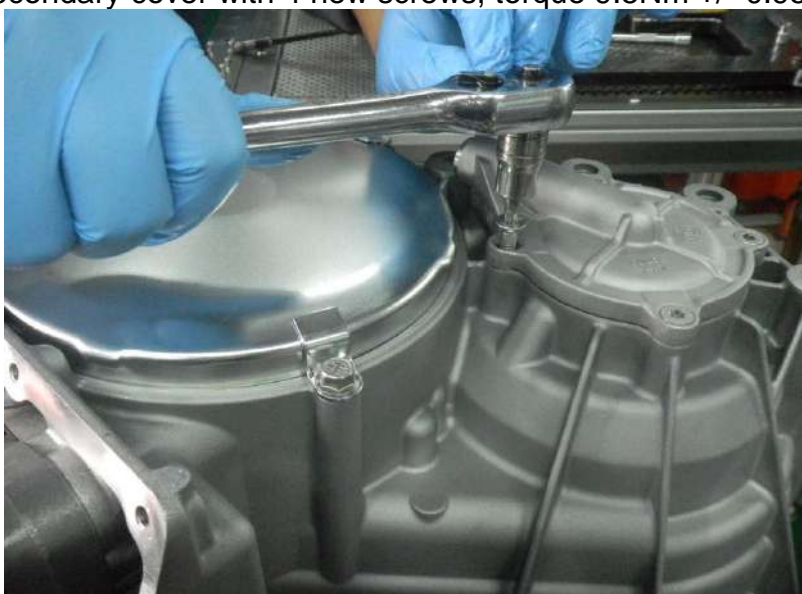
Fig.1 : Take off secondary cover bolt

- The transmission does not need to be removed from the vehicle but may be lowered together with the engine for easier access
- Loosen the four screws and discard screws
- Take off secondary cover, remove the small and bigger O-ring and the center sealing ring
- In case of damaged cover, take a new secondary cover
- Replace new O-rings and sealing ring
- Remove the glue (glue from the sealant screws) gently from the transmission housing
- Tighten the secondary cover with 4 new screws, torque 9.5Nm +/- 0.95Nm

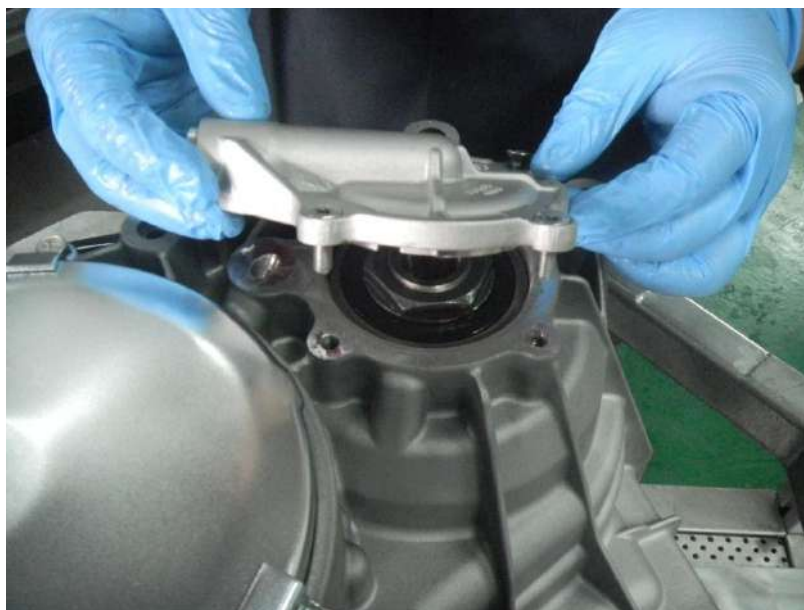
Fig.2 : remove secondary cover

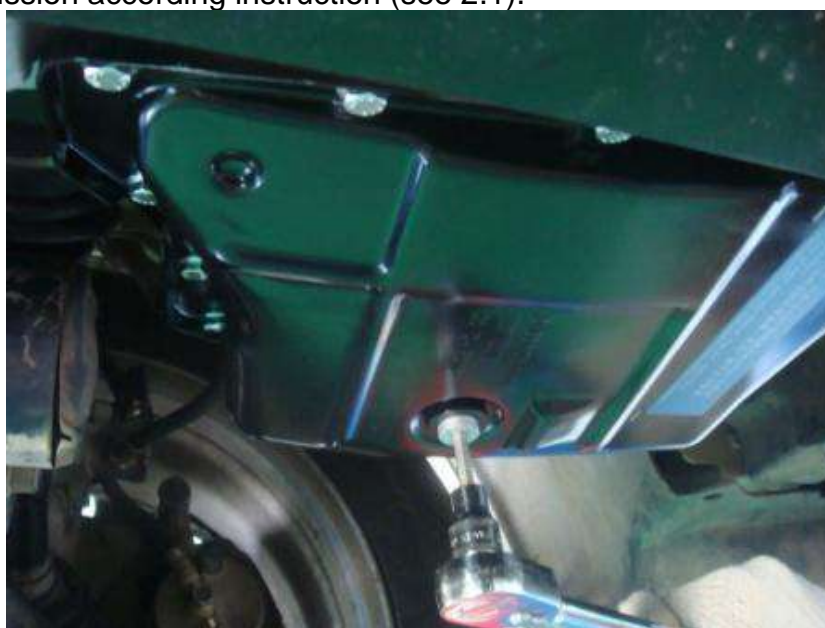
Fig. 9-1 Remove oil drain plug

- Drain the oil by removing the oil drain plug (see Fig. 9-1)
- Let all oil drip out, discard old drain plug
- Remove oil pan by unscrewing all 13 screws from the oil pan (see Fig. 9-2)
- Discard the oil pan gasket and oil pan
- Take new oil pan and gasket
- Fix oil pan with new gasket by tightening the screws according to Fig. 9-3 with 9.5Nm +/- 1Nm
- Refill transmission according instruction (see 2.1).

- Drain the oil by removing the oil drain plug (see Fig. 9-1)
- Let all oil drip out, discard old drain plug
- Refit new drain plug and tighten with 11Nm +/-1Nm
- Remove oil pan by unscrewing all 13 screws from the oil pan (see Fig. 9-2)

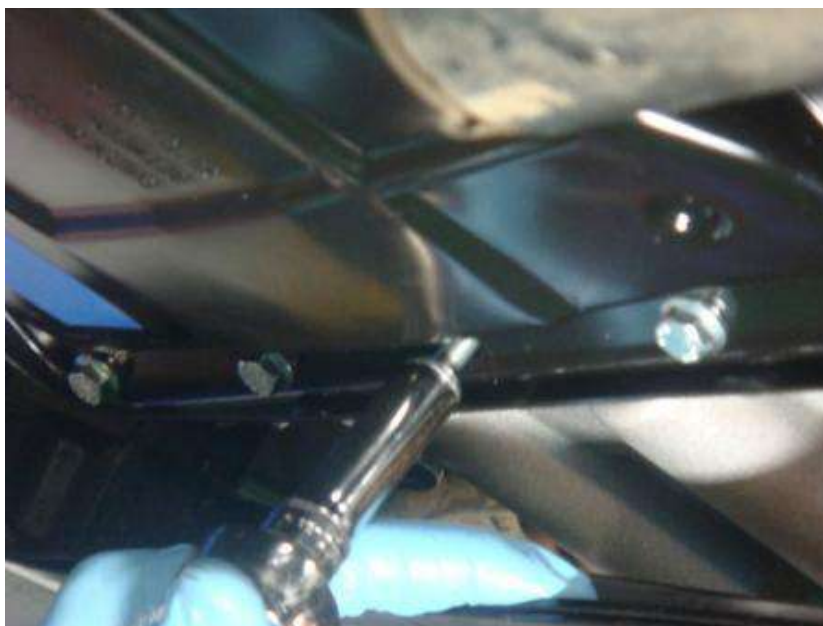
Fig. 9-2 Removing the oil pan

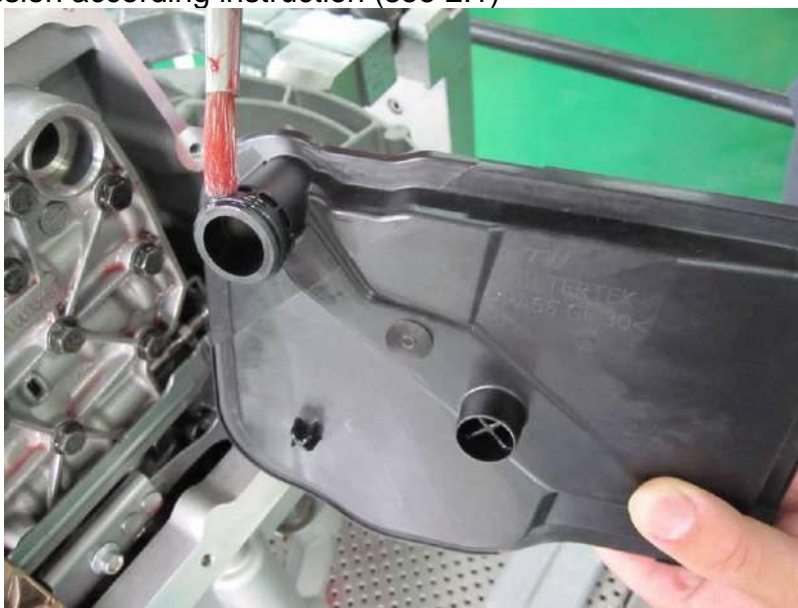
Fig. 10-1: Lubricate the O-ring

- Discard the oil pan gasket
- Remove the oil filter by pulling it gently, discard oil filter
- Take new filter with O-ring and lubricate the O-ring with clean ESSO EZL799(A) (see Fig. 10-1)
- Press in gently the new oil filter and position correctly (centre hole of oil filter should match centre bolt of hydraulic unit) (see Fig. 10-2)
- Clean magnet and surface of oil pan and place a new oil pan gasket
- Place oil pan with new gasket in place and tighten the 13 screws according to Fig. 9-3 with 9.5Nm +/- 1Nm
- Refill transmission according instruction (see 2.1)

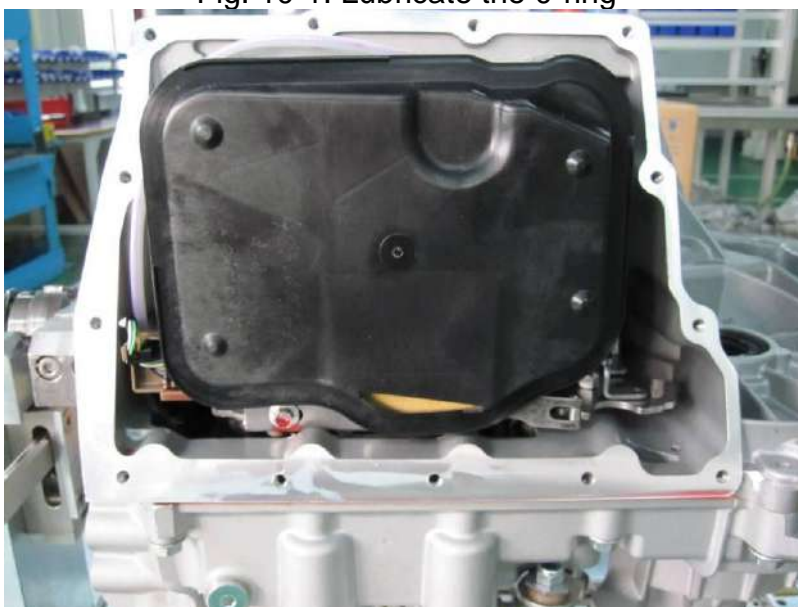
Fig. 10-2: Fix oil filter in position

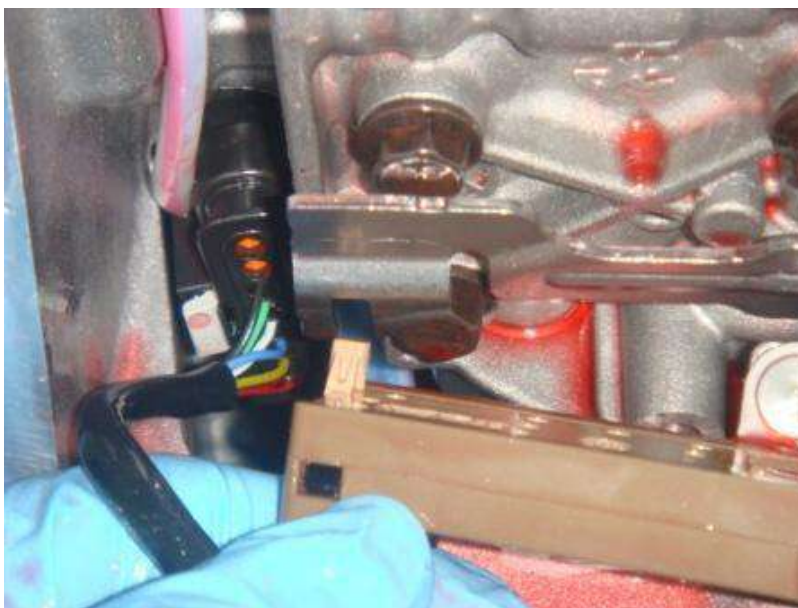
Fig. 11-4: Pin locked in dedicated space of the metal slide

- Take a new drive mode sensor, connect the connector to the main cable harness and lock it by pushing the gray lock button
- Place drive mode sensor against the metal slide, with the pin on the back of the sensor locked in the dedicated space on the slide (see Fig. 11-4)

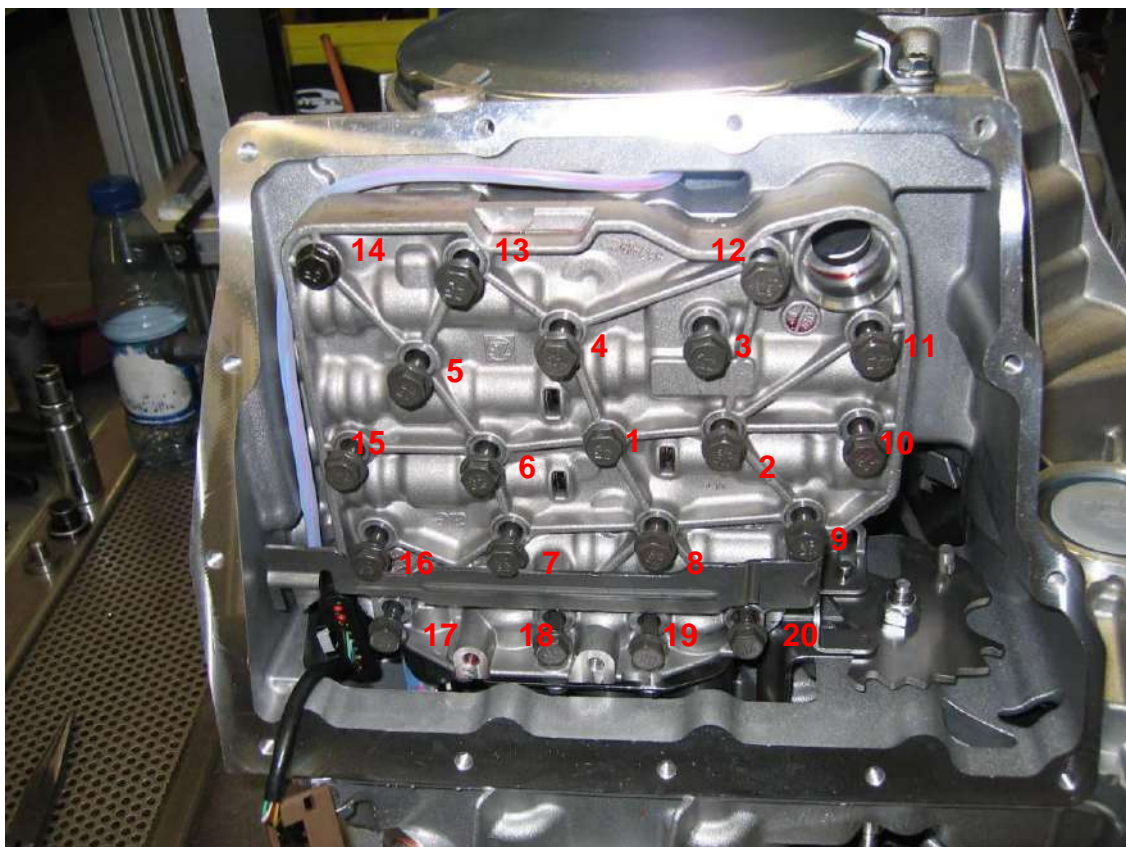
Fig. 12-1: Order of the bolts

- Follow steps to remove the drive mode sensor
- Follow the sequence on Fig. 12-1 in reverse order 20-19-18-17-16-15-14-13-12-11-10-9-8-7-6-5-4-3-2-1 to unscrew all hydraulic unit bolts

- Place all screws of hydraulic unit, except the upper left one and tighten with 11Nm +/- 1Nm in sequence 1-2-3-4-5-6-7-8-9-10-11-12-13-14-15-16-17-18-19-20 on Fig. 11-1 When arriving at the upper left one, take out special tool and replace with screw and continue until screw 20.

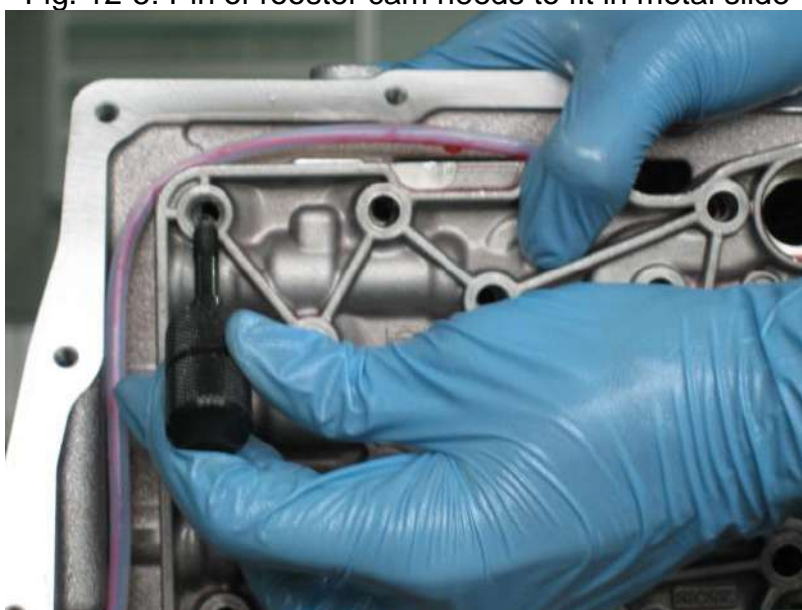
Fig. 12-6: Special alignment (480142) tool for hydr. unit

- Place the center screw and hand tighten it
- Place the special alignment tool (480142) on the top left screw hole and screw it in (see Fig. 12-6)
- Push the speed sensor cable behind the upper left corner of the hydraulic unit (see Fig. 12-6)

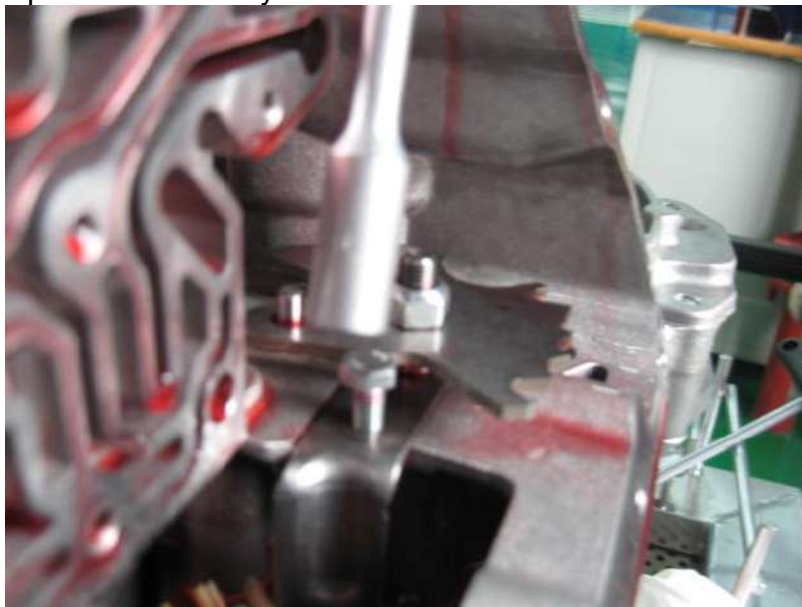
Fig. 13-1: Loosen bolt bracket output speed sensor

- Follow steps to remove the hydraulic unit
- Loosen bolt bracket output speedsensor and discard bolt (see Fig. 13-1)
- Slide out the bracket, there is a dedicated sleeve in the selector shaft! (see Fig. 13-2)
- Disconnect cable from speedsensor with long flat nose pliers (see Fig. 13-3)
- Remove sensor from bracket by unscrewing bolt
- Discard sensor and/or bracket

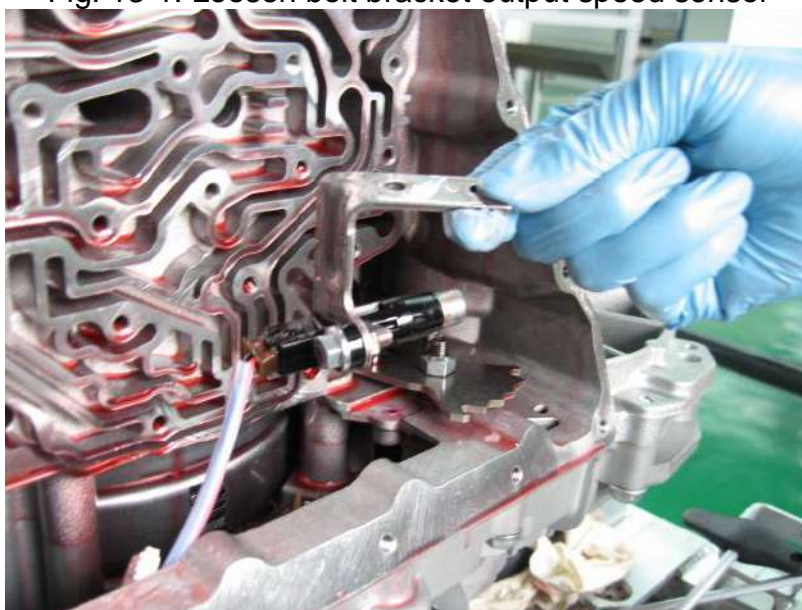
Fig. 13-2: Bracket output speed sensor

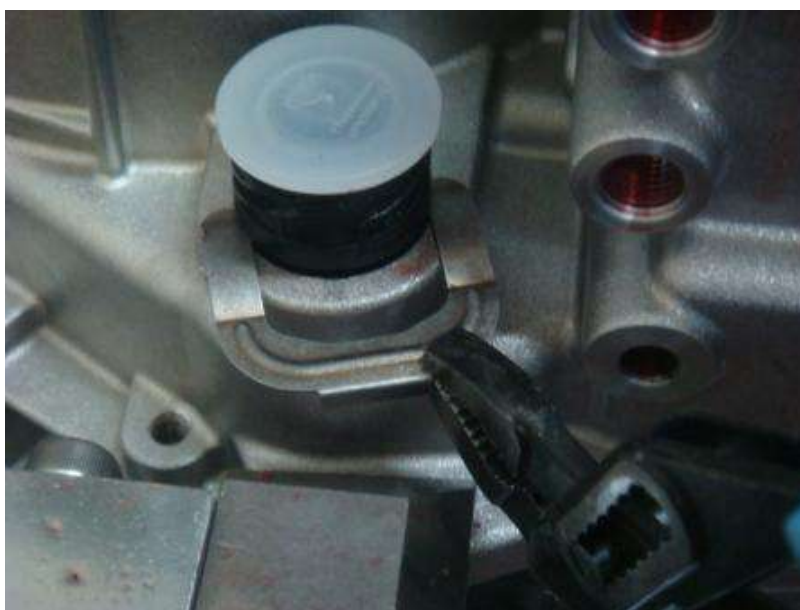
Fig. 15-1: Remove the clip from the main connector

- Follow steps to remove hydraulic unit
- Disconnect output speed sensor
- Disconnect the car cable harness connector from the main connector on the transmission
- Remove the clip with pliers and push the main connector into the transmission (see Fig. 15-1, 15-2)
- The drive mode sensor connector is clipped on the transmission, loosen that one first (see Fig. 15-3)
- Remove the complete cable harness from the transmission and discard
- Take new cable harness and put into transmission
- The main connector has a sleeve which should fit over the securing key on Fig. 15-4, 15-5
- The use of a 45deg angled nose pliers can be helpful to fit in the main connector
- Push clip back on main connector
- Push drive mode sensor connector on the transmission (see Fig. 15-6)
- Connect the output speed sensor
- Follow steps to place back the hydraulic unit

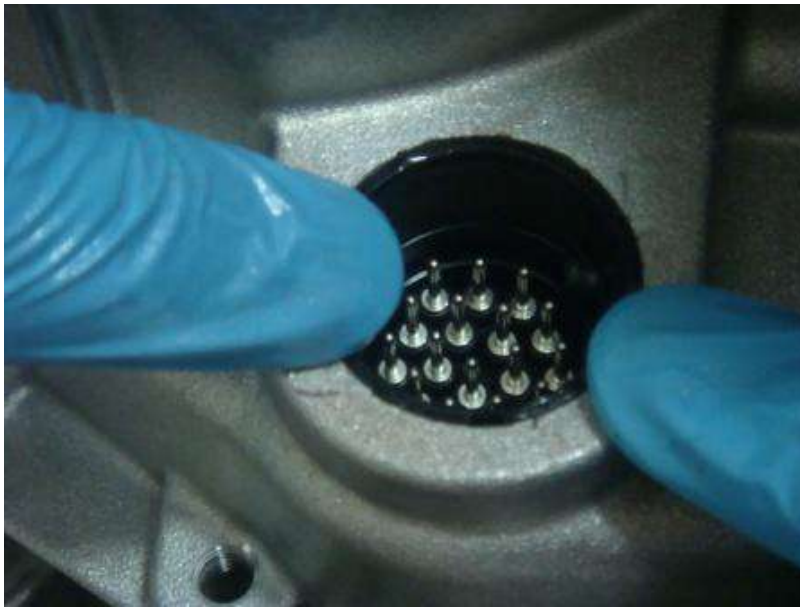
Fig. 15-2: Push main connector into the transmission

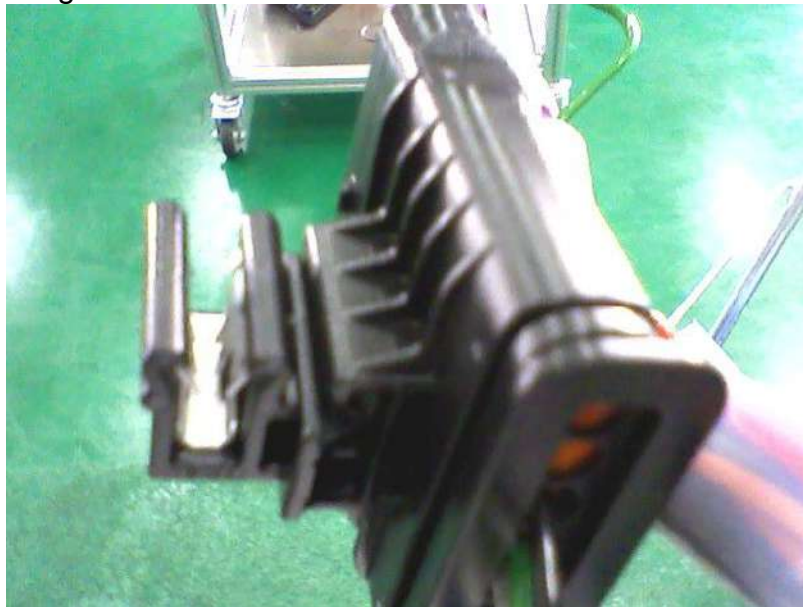
Fig. 15-3: Remove drive mode sensor connector from transmission

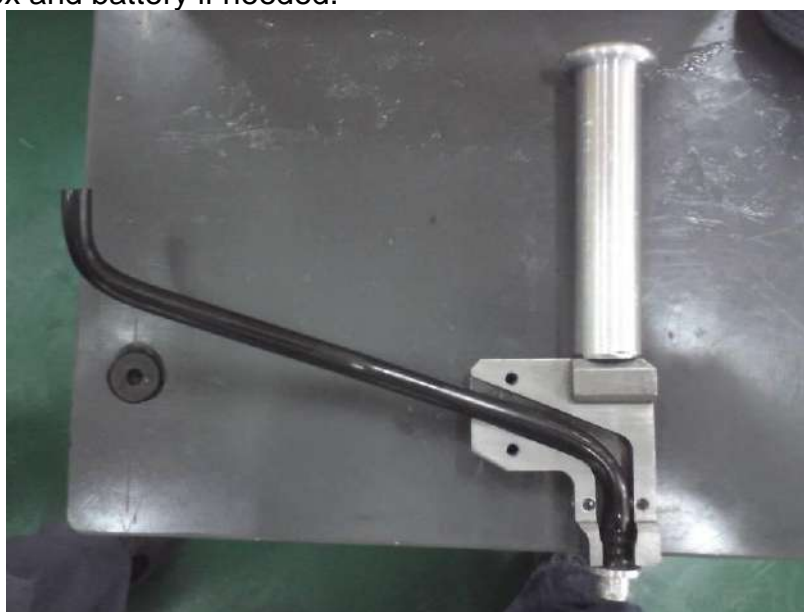
Fig. 16-1: Place the new breather pipe into the assembly tool

- Place the new breather pipe (483114) into the special tool (480140), see Fig. 16-1. Put a little amount of Vaseline on the Aluminum piece of the breather pipe.
- Place tool and breather pipe onto the transmission housing so the pipe runs about parallel with the transmission, Fig. 16-2. Hammer down gently the breather pipe into the transmission house till the end by using a plastic hammer on top of the special tool.
- Put the plastic clip (482253) around the pipe.
- Put the pins of the plastic clip thru the hole of the metal clip (481456).
- Push the metal clip firmly (till the end) onto the ridge of the transmission house.
- Slide the breather cap (483117) complete over the top of the breather pipe. Fig. 16-3
- Replace airbox and battery if needed.

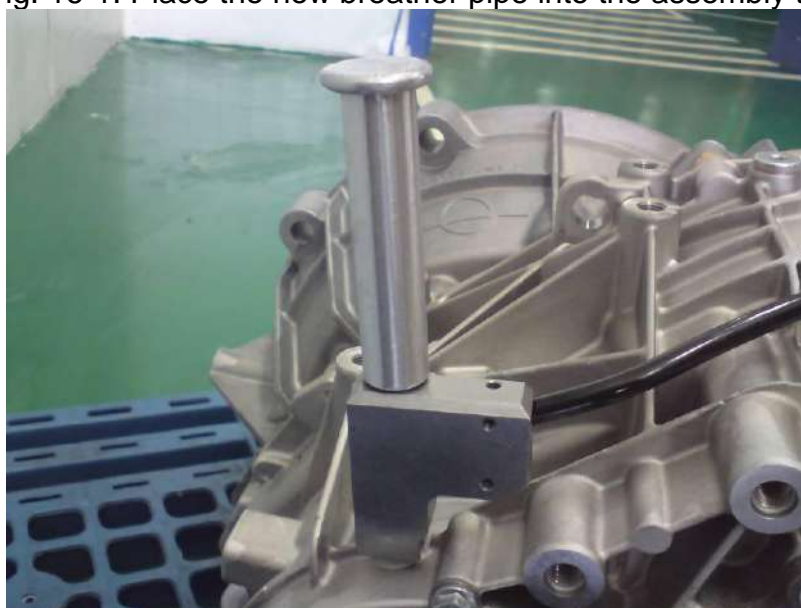
Fig. 16-2: Hammer down the tool till the end with plastic hammer

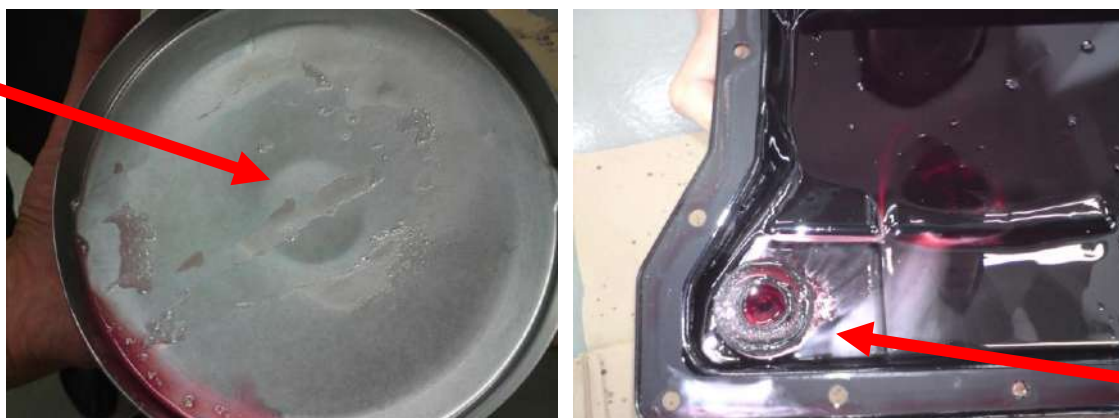
If the inside of primary cover and oil pan shows white stuff inside, than it is fully clear the transmission has been contaminated with water or other oil or liquid.
